Landslides and sediment cascade triggered by the 14 November 2016, M_w 7.8 Earthquake, Kaikoura, New Zealand

Phaedra Upton¹

Kaikōura Earthquake

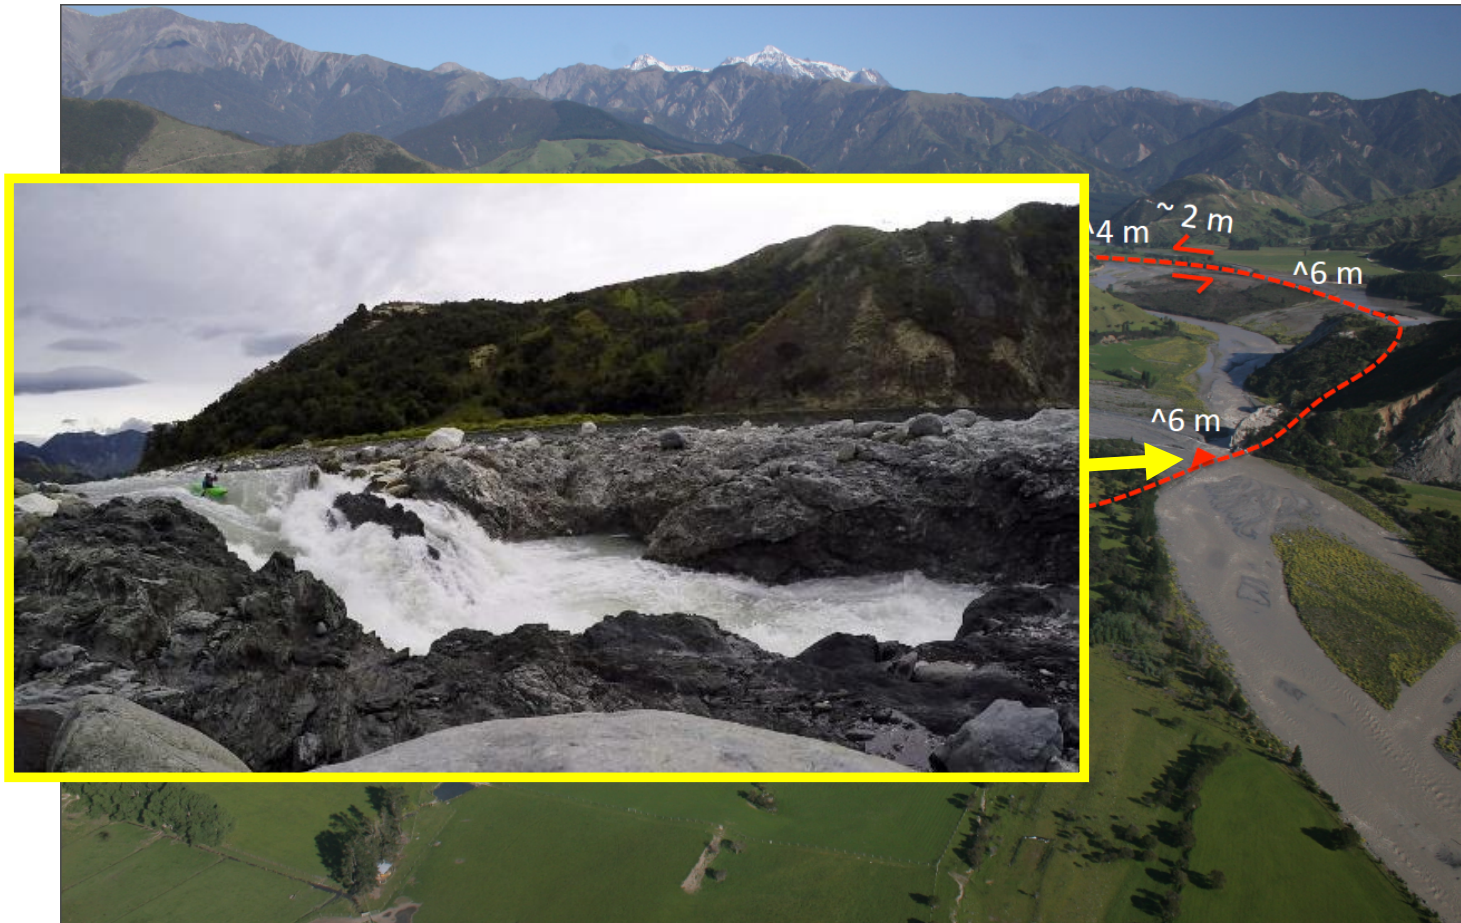
Papatea Fault

Rupture crosses the Clarence River in several places

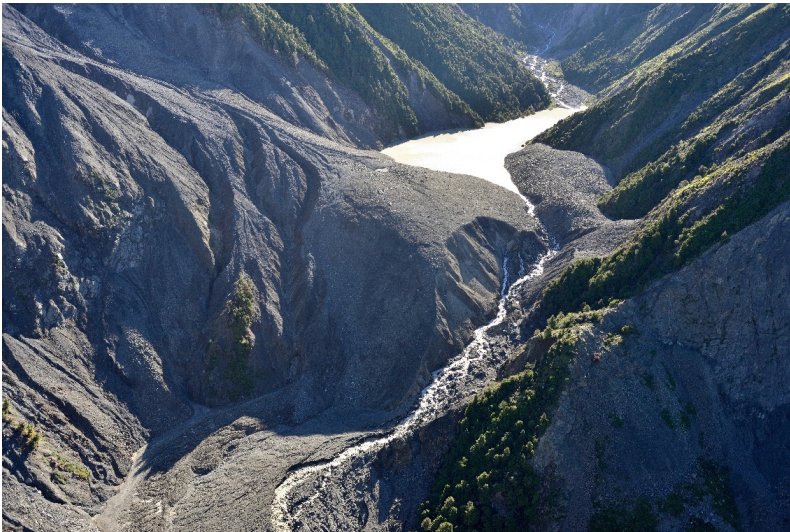
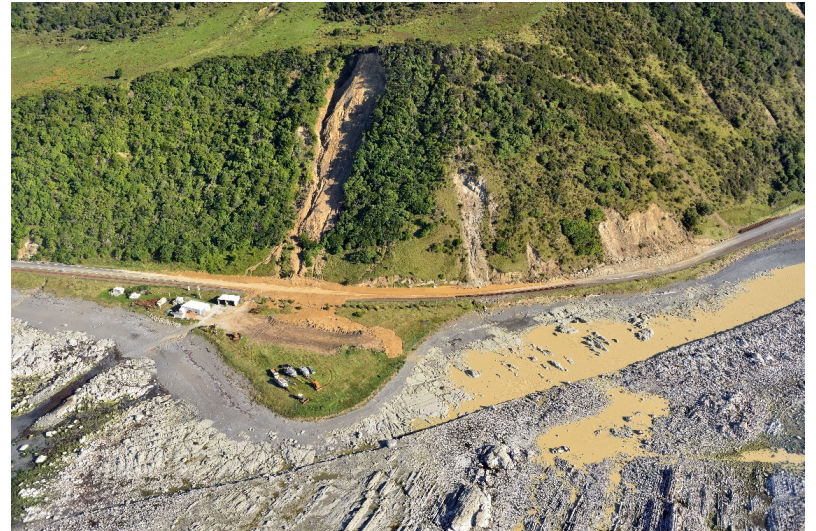
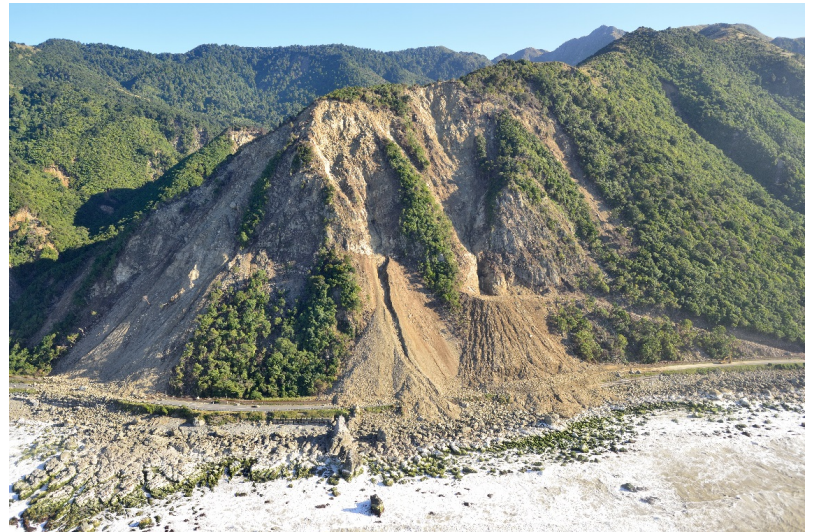
Post earthquake landsliding (Cyclone Debbie 2017)

- Hapuku dam overtopped and eroded
- Many debris flows from the cracked terraces at the crests of the coastal cliffs
- Many blocked SH1 again

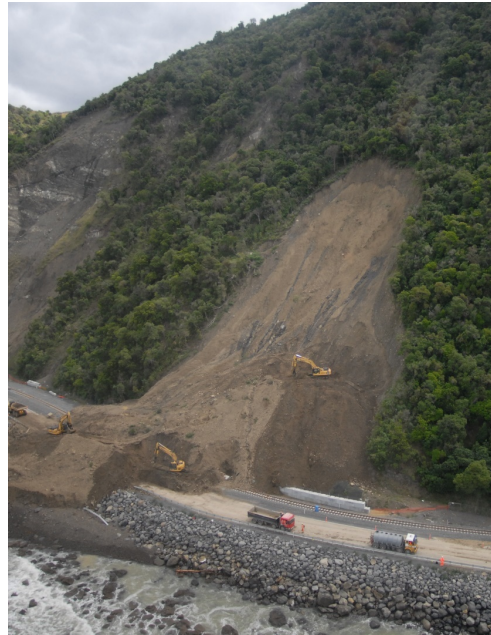
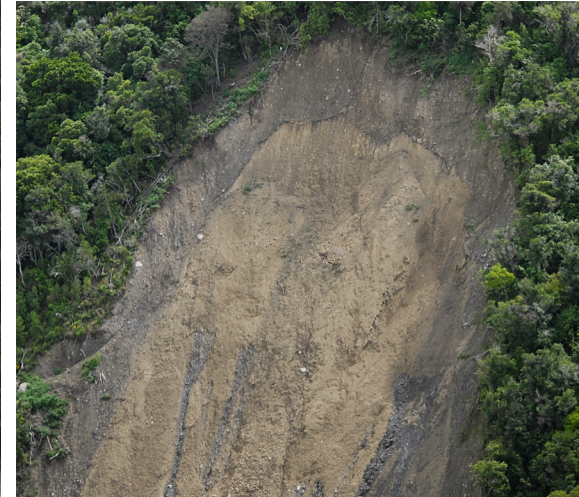
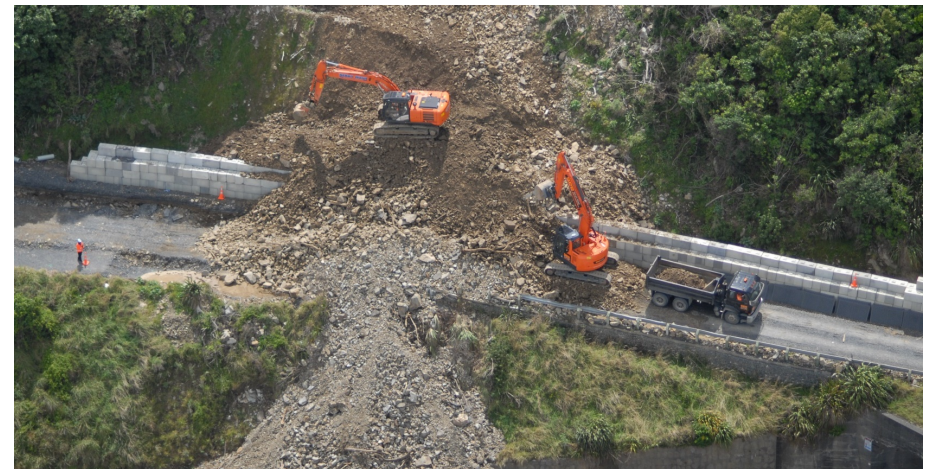
Post earthquake landsliding (Ex-Cyclone Gita 2018)

- Rainfall highly localised on coast
- Kaikoura 270 mm in 12 hours
- Estimated 300000m³ debris covered road and rail
- Most occurred in locations where the slope had been damaged by the EQ
 - Remobilisation of debris
 - Enlargement of the source areas
 - Remobilisation of debris in streams
- Many blocked SH1 for > week

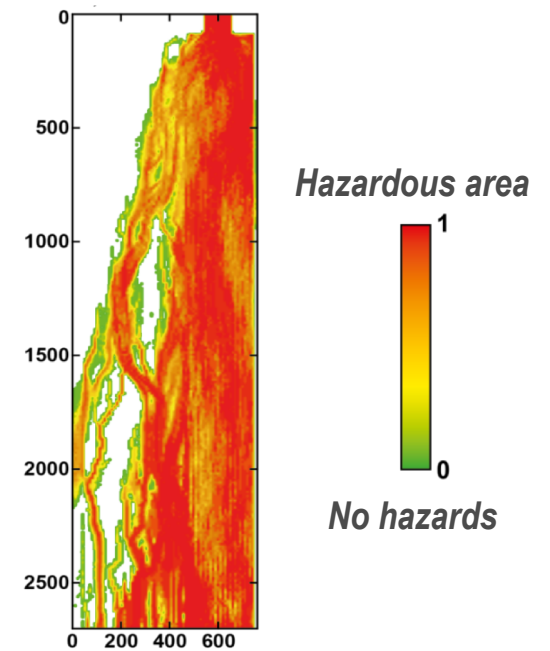
Probability of cell flooding
