Links between the human dimension and long term tectonics: Mw 7.8 Kaikoura Earthquake, South Island New Zealand, 14th November 2016

Phaedra Upton

¹GNS Science, PO Box 30368, Lower Hutt

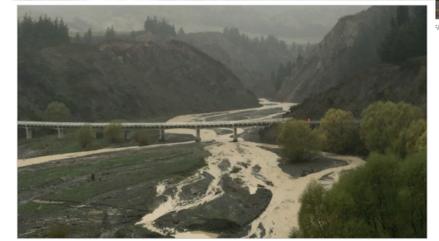
Slip damage at the Conway River bridge during heavy rainfall in the area on Wednesday. PIPPA BROWN/STUFF

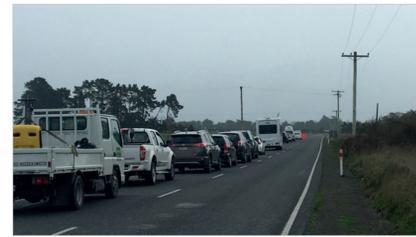
Cars wait at the road block on the Inland Road, route 70, through Mount Lyford and Waiatu, for the road to open. PIPPA BROWN

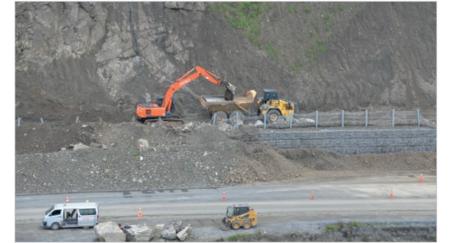
State Highway 1 south of Kaikoura, between Peketa and Goose Bay, was closed for eight days while work was carried out stabilising major slips. MARCUS GRIBBS

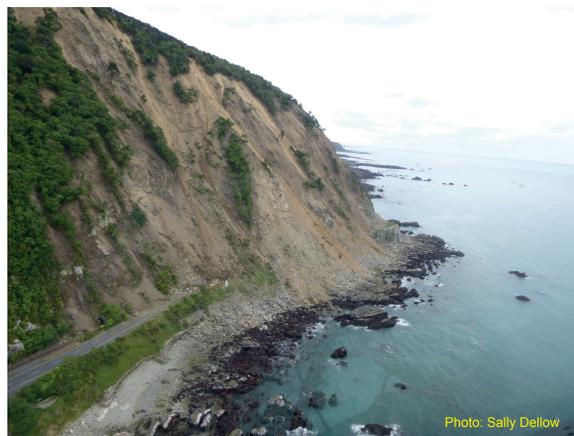
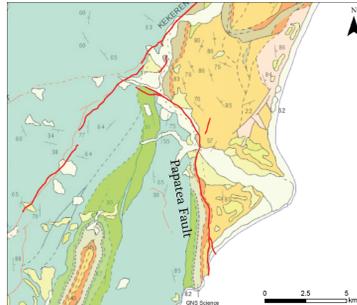
Two of the faults that ruptured during the earthquake; the Kekerengu and the Papatea faults.

Several large landslides occurred along the Papatea Fault, which juxtaposes Cretaceous and Miocene rocks.

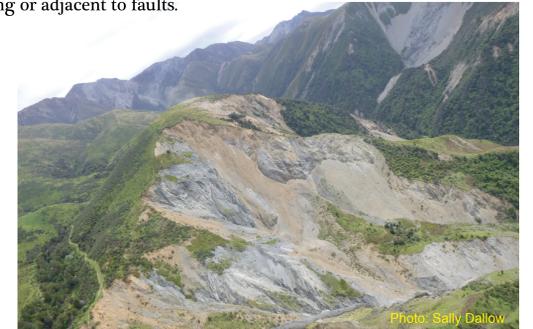
Landslides along the Hope Fault triggered by the Kaikoura Earthquake. Although the Hope Fault was notable during the earthquake for being a major fault that didn't rupture, in fact the rupture jumped across it, rock weakened by previous fault ruptures made it susceptible to landsliding.
