# The Rio Puerco, New Mexico: a story of changing river morphology and invasive species

# Rio Puerco, New Mexico:

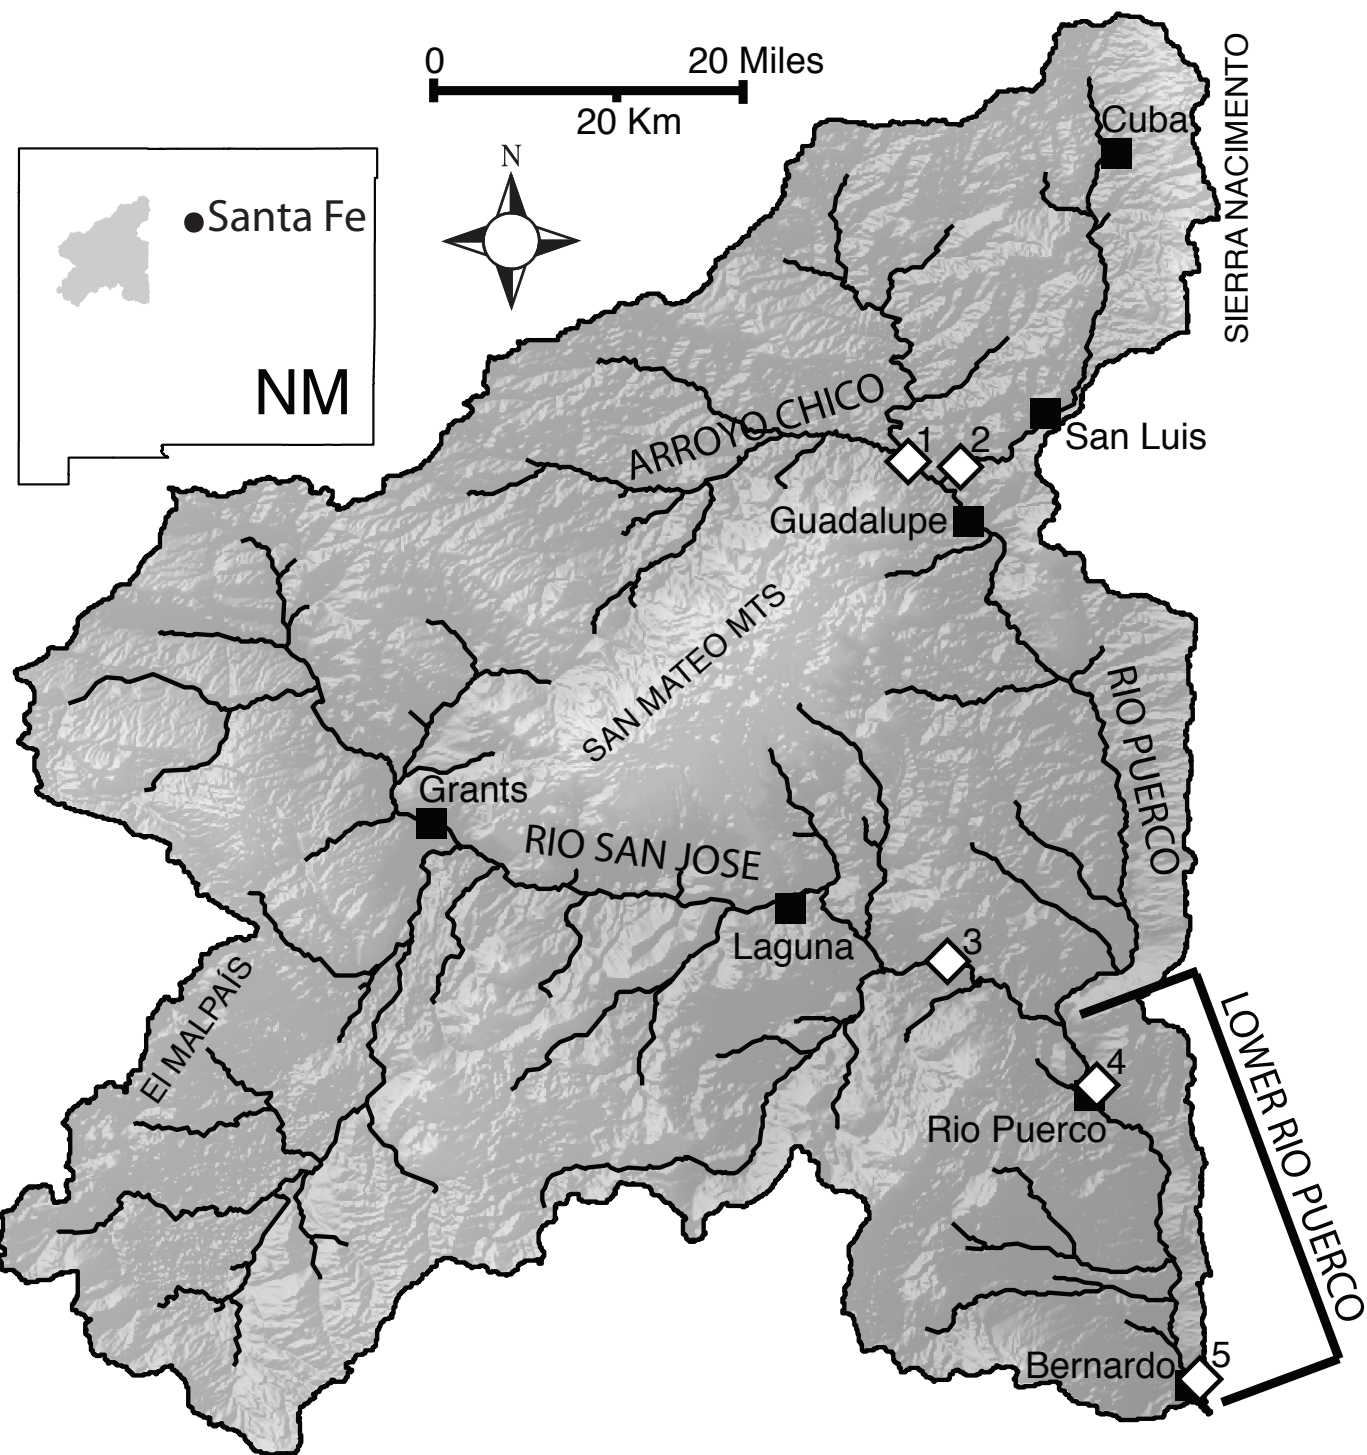
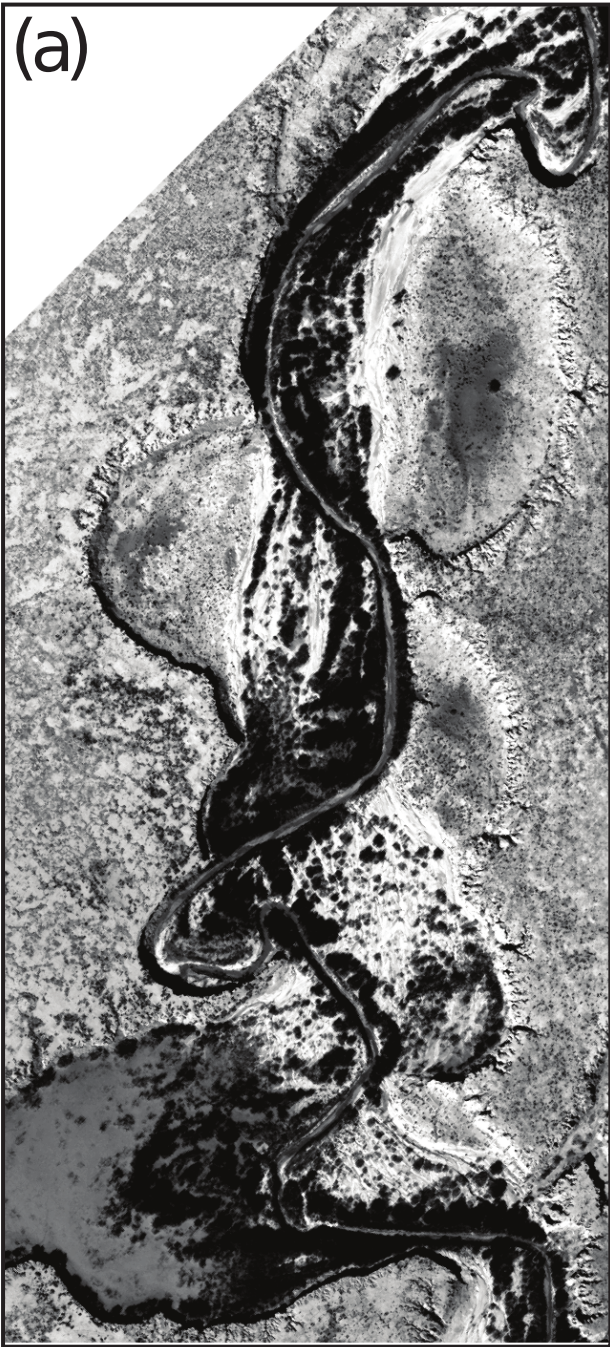
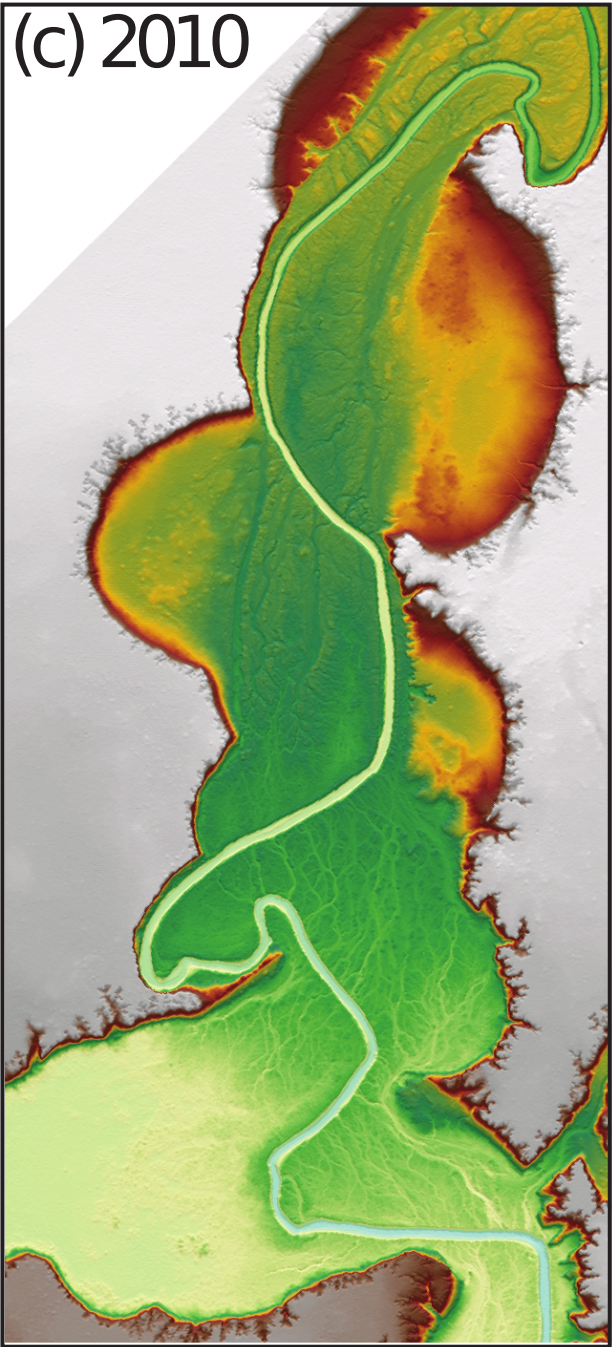
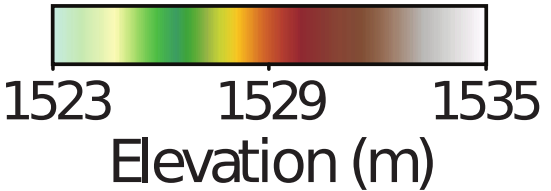
Modern geometry:

**vertical** walls

**flat, vegetated** arroyo bottom

**narrow** channel

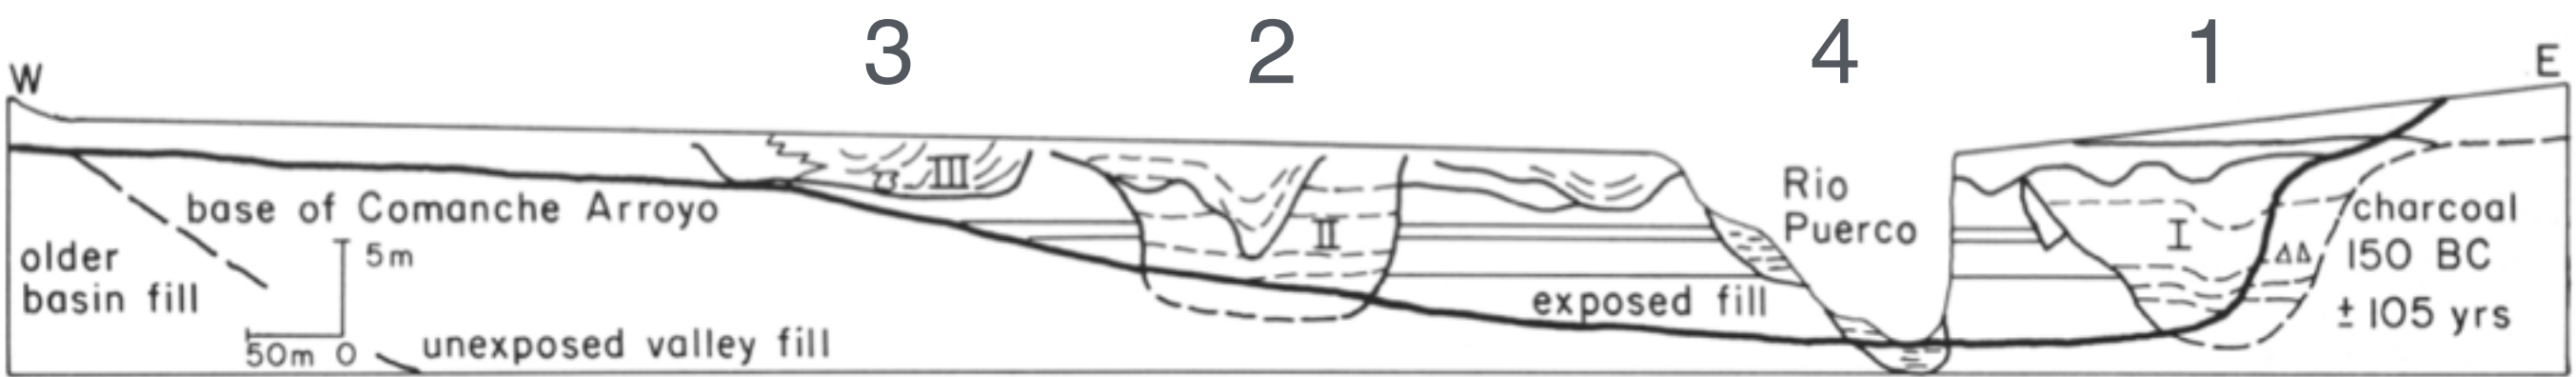
At least **3 cut-and-fill cycles** in last 3000 years

Figure 5. Schematic cross section of Rio Puerco valley fill near the mouth of Comanche Arroyo. Numbered channels are discussed in text.

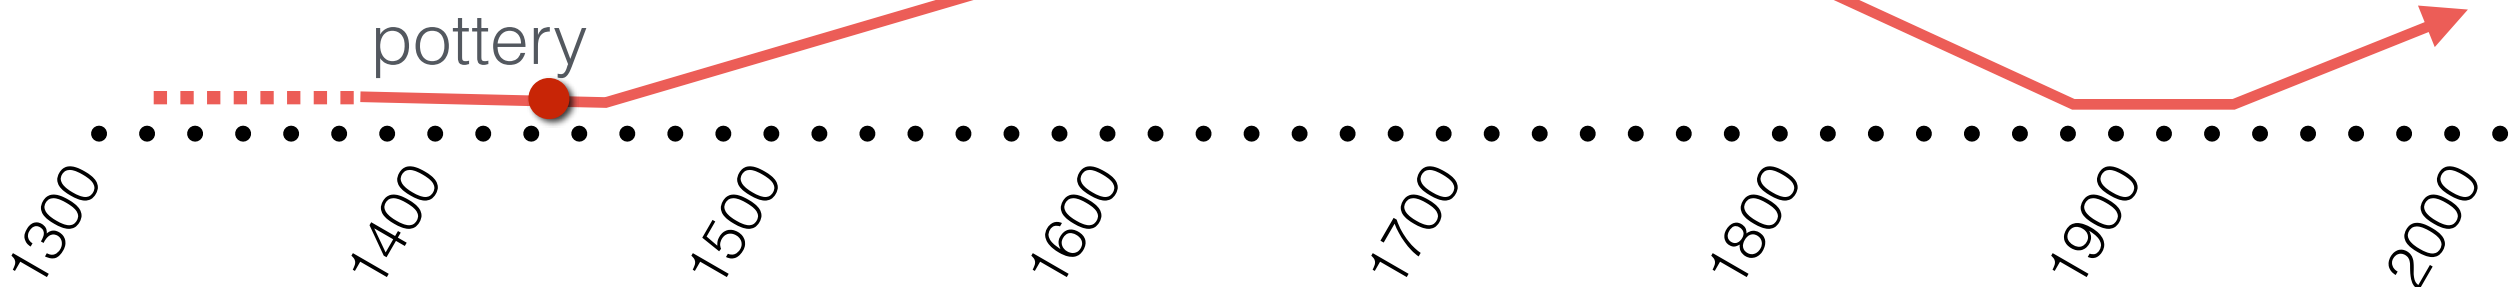
1325 - 1450

ARROYO BOTTOM  
ELEVATION

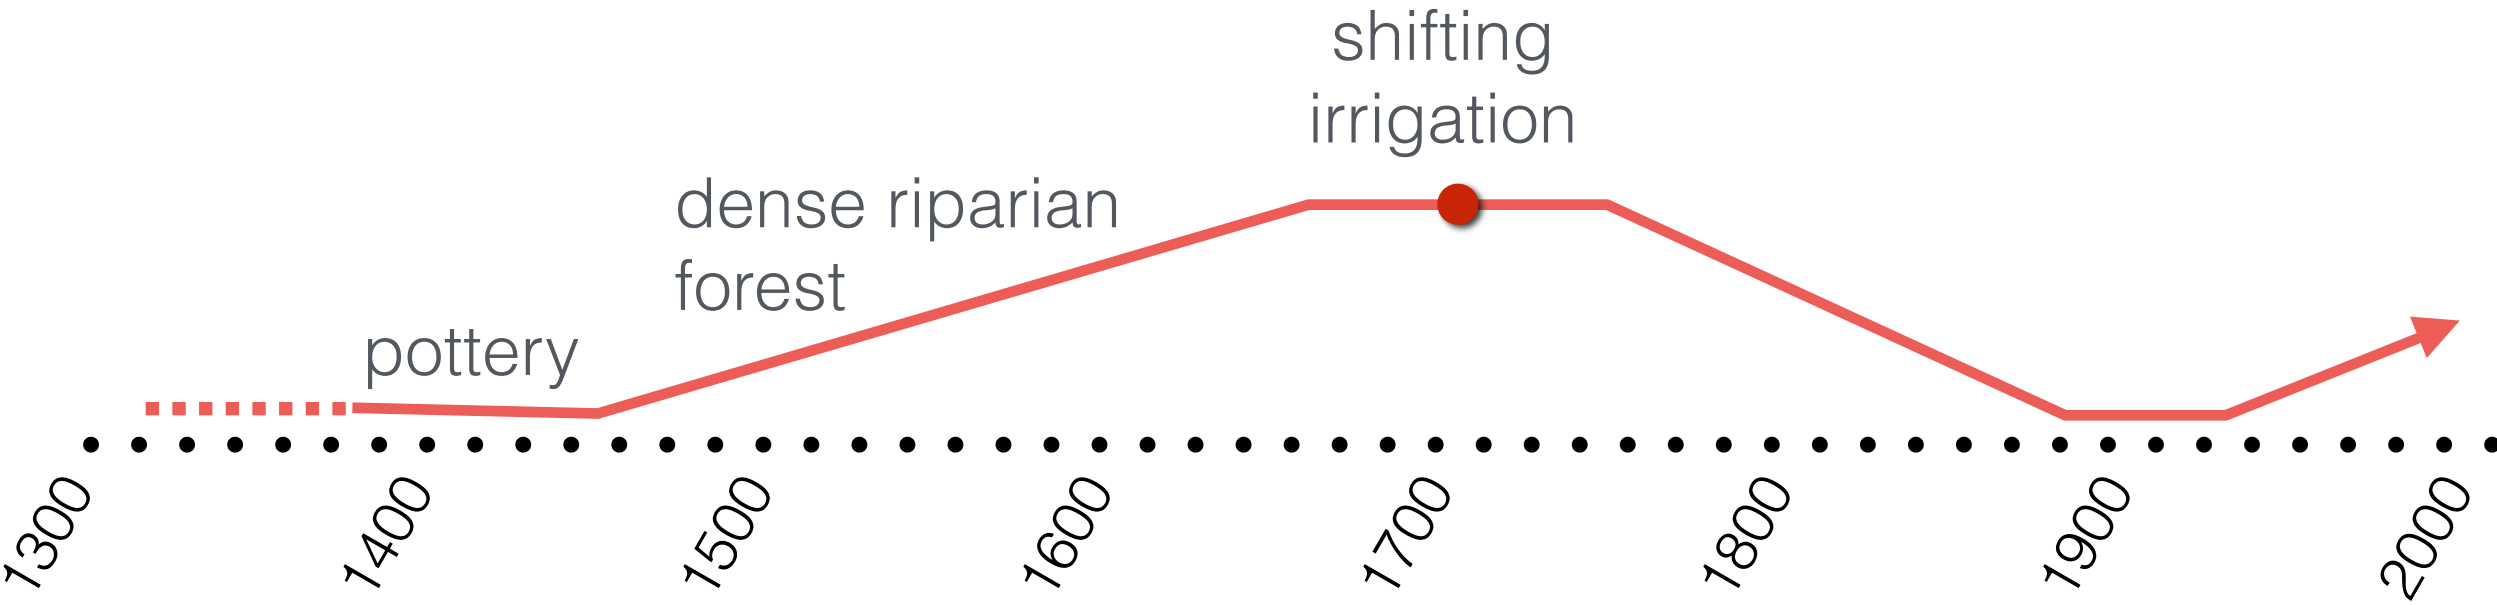
~1700

ARROYO BOTTOM  
ELEVATION

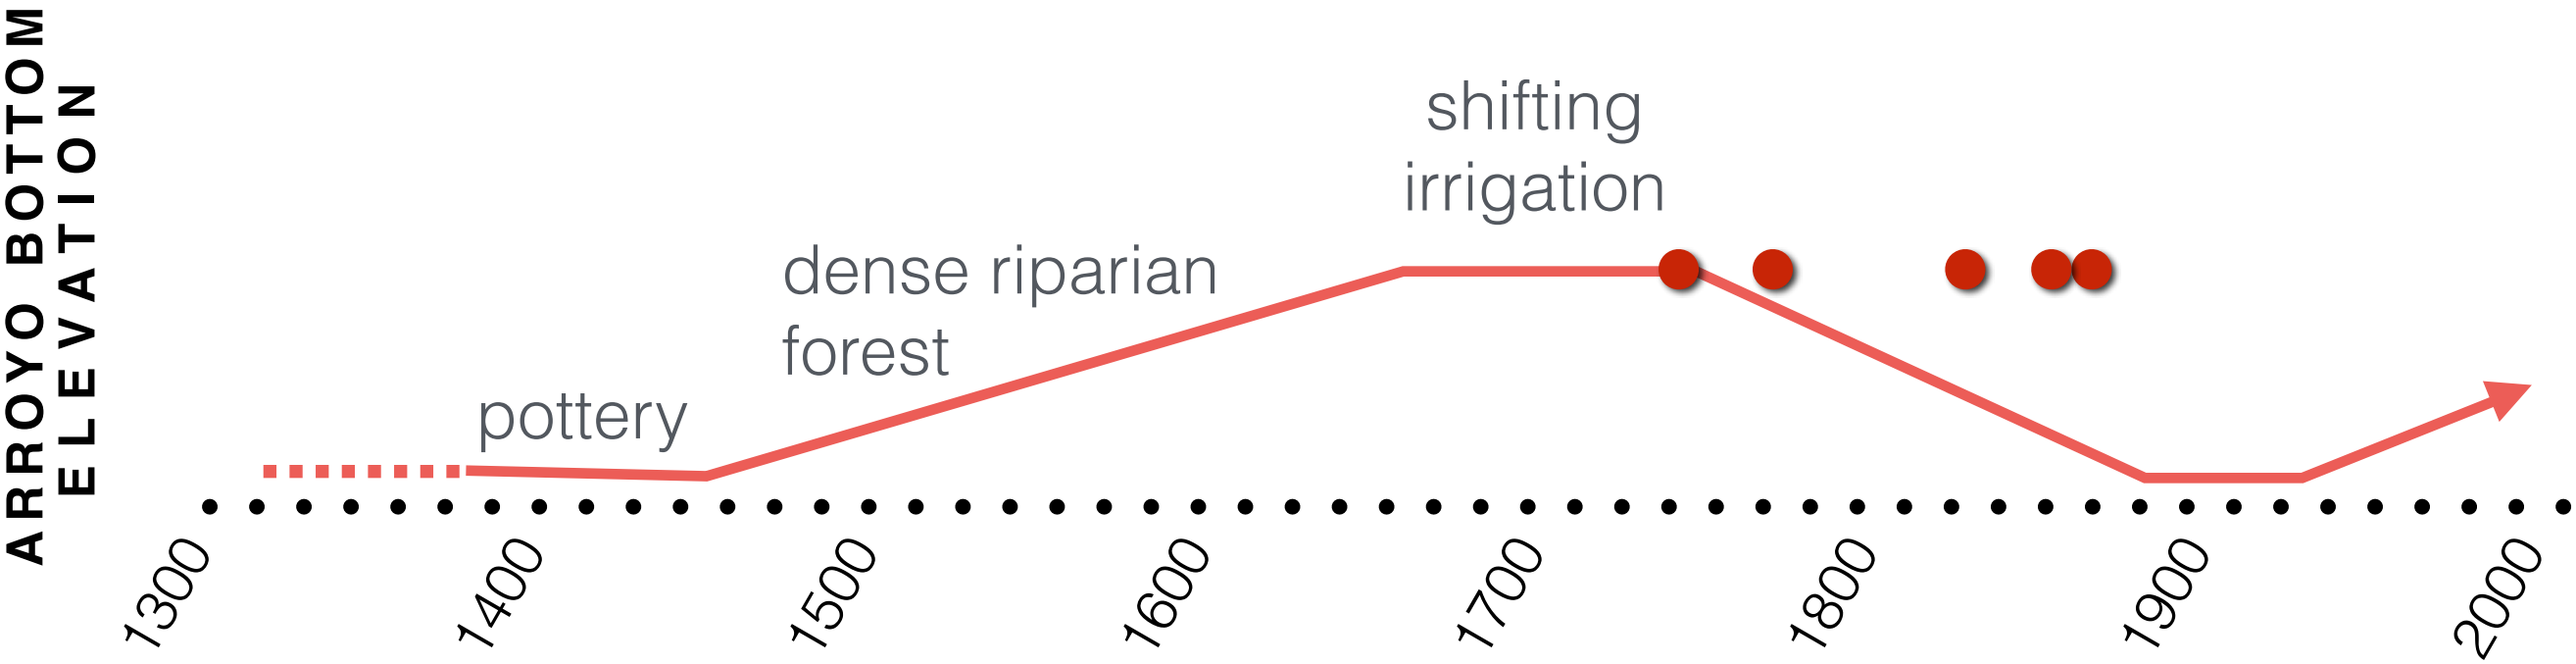
Bernardo: 1760  
South of Hwy 6: 1881  
At Rio San Jose: 1765  
Poblazón: 1846  
Cabezón: 1888

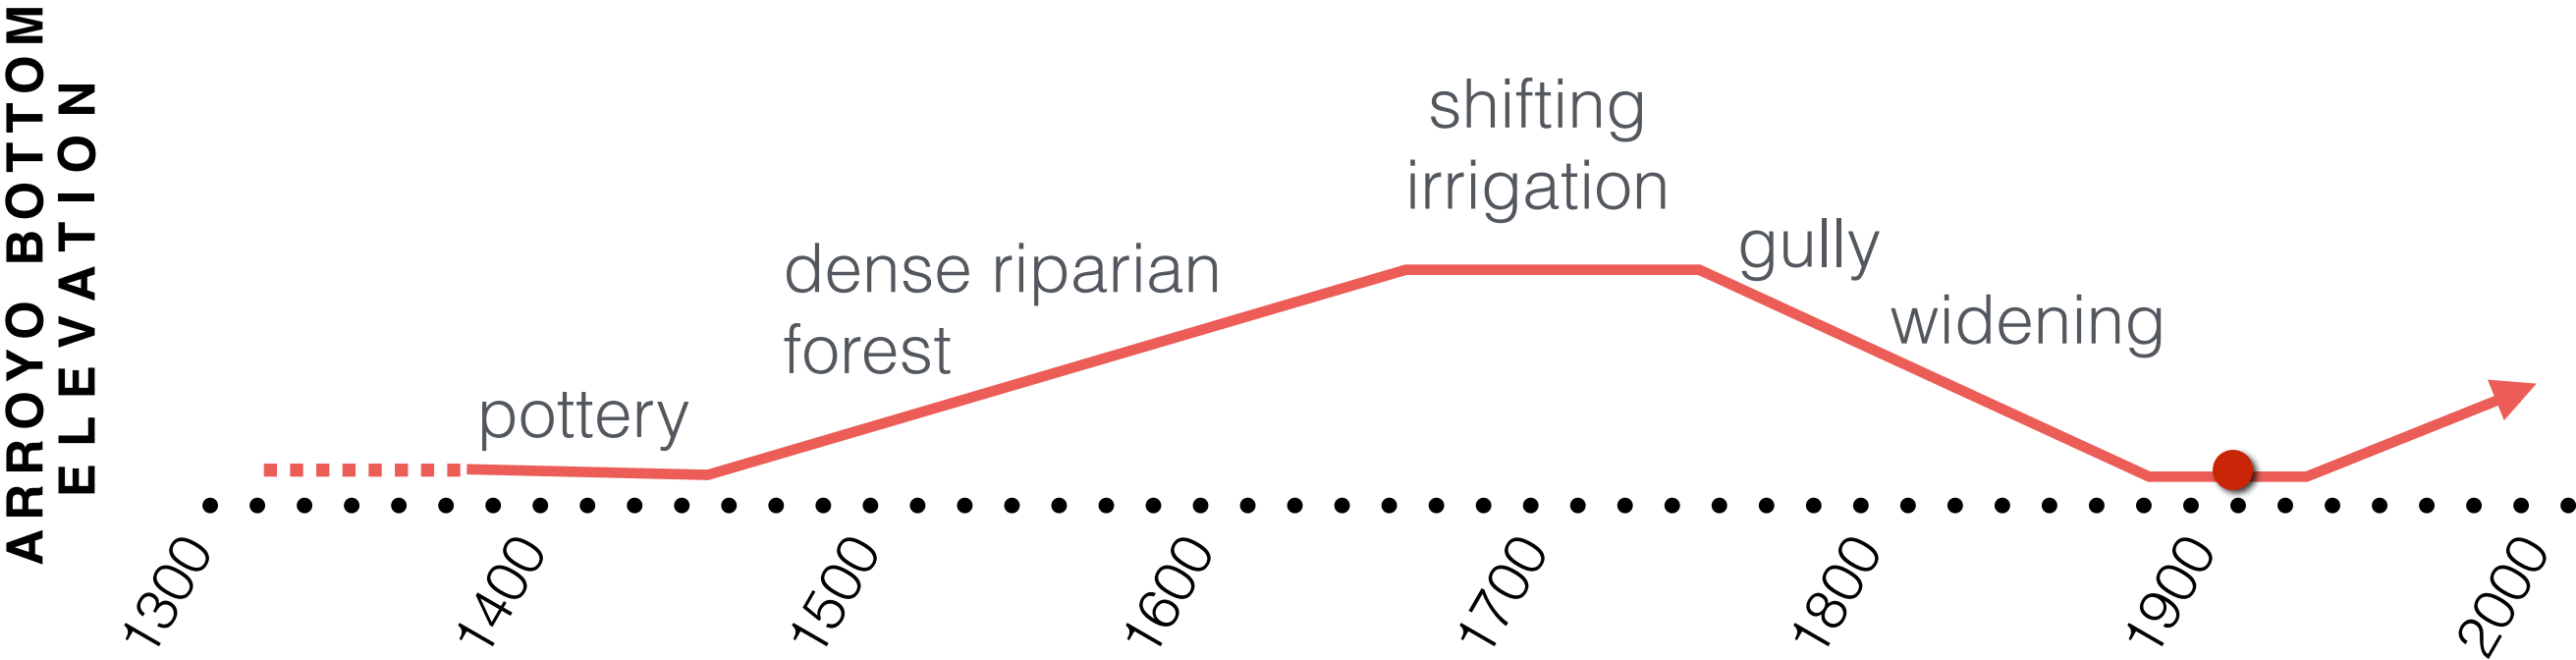
1880s-1930s

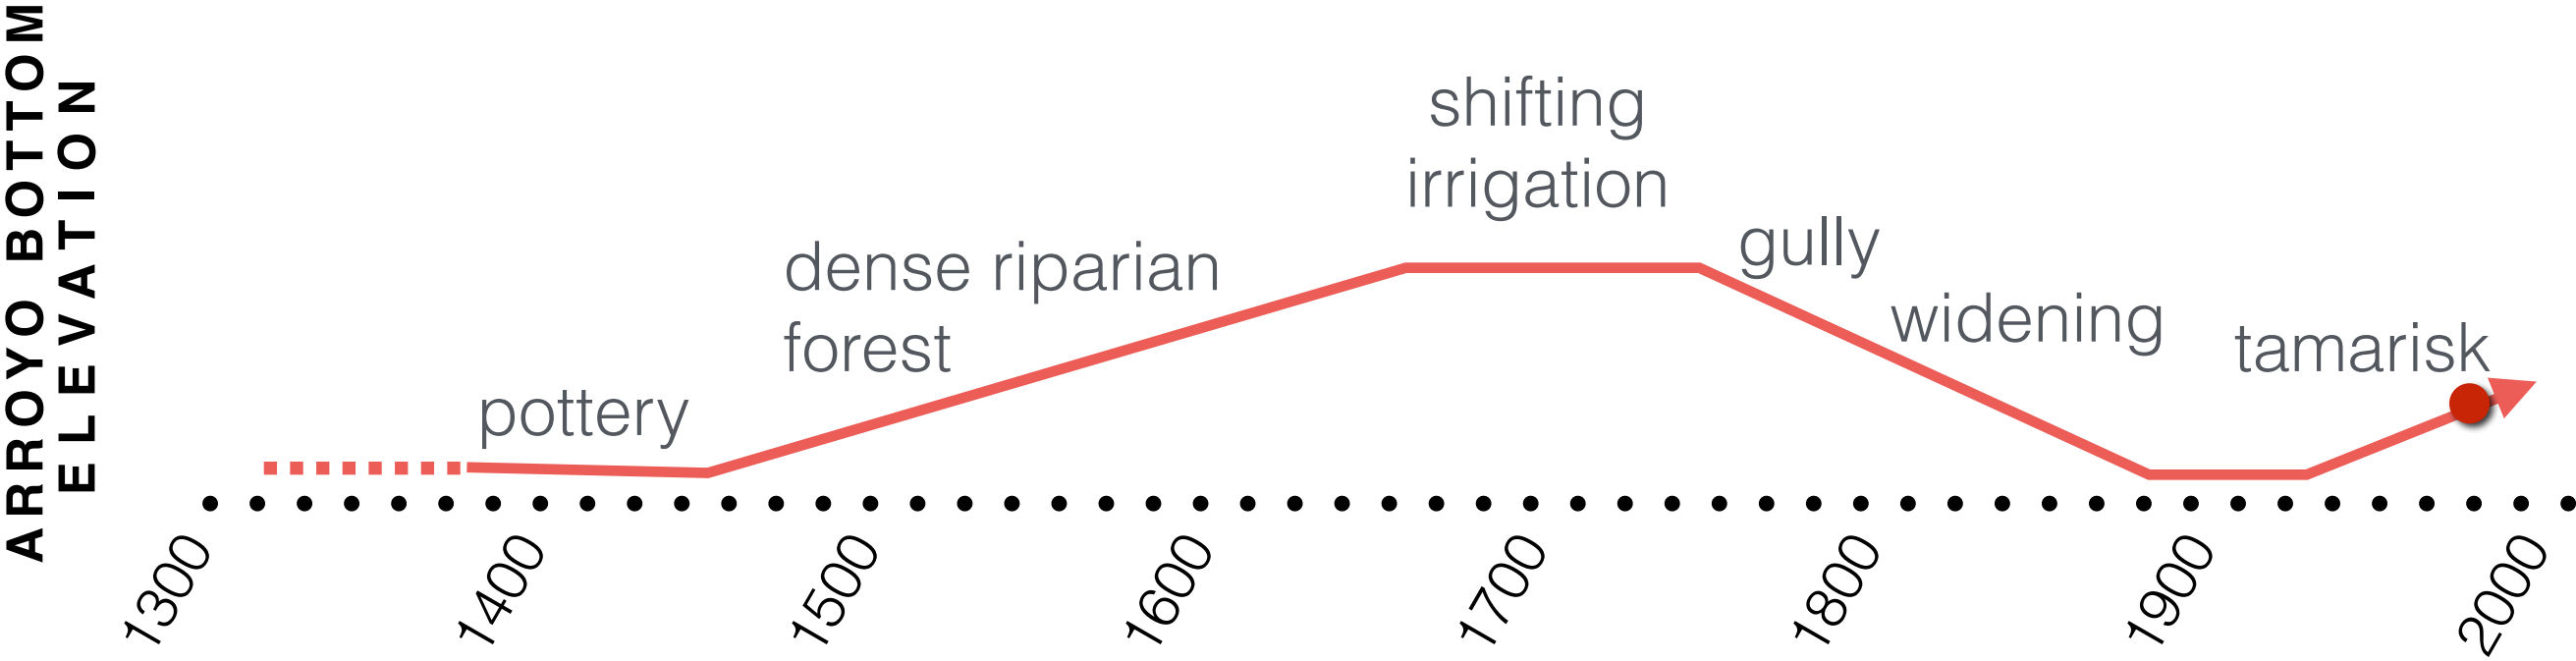
1930s-present

**Deepest in 1930s**

Now filling

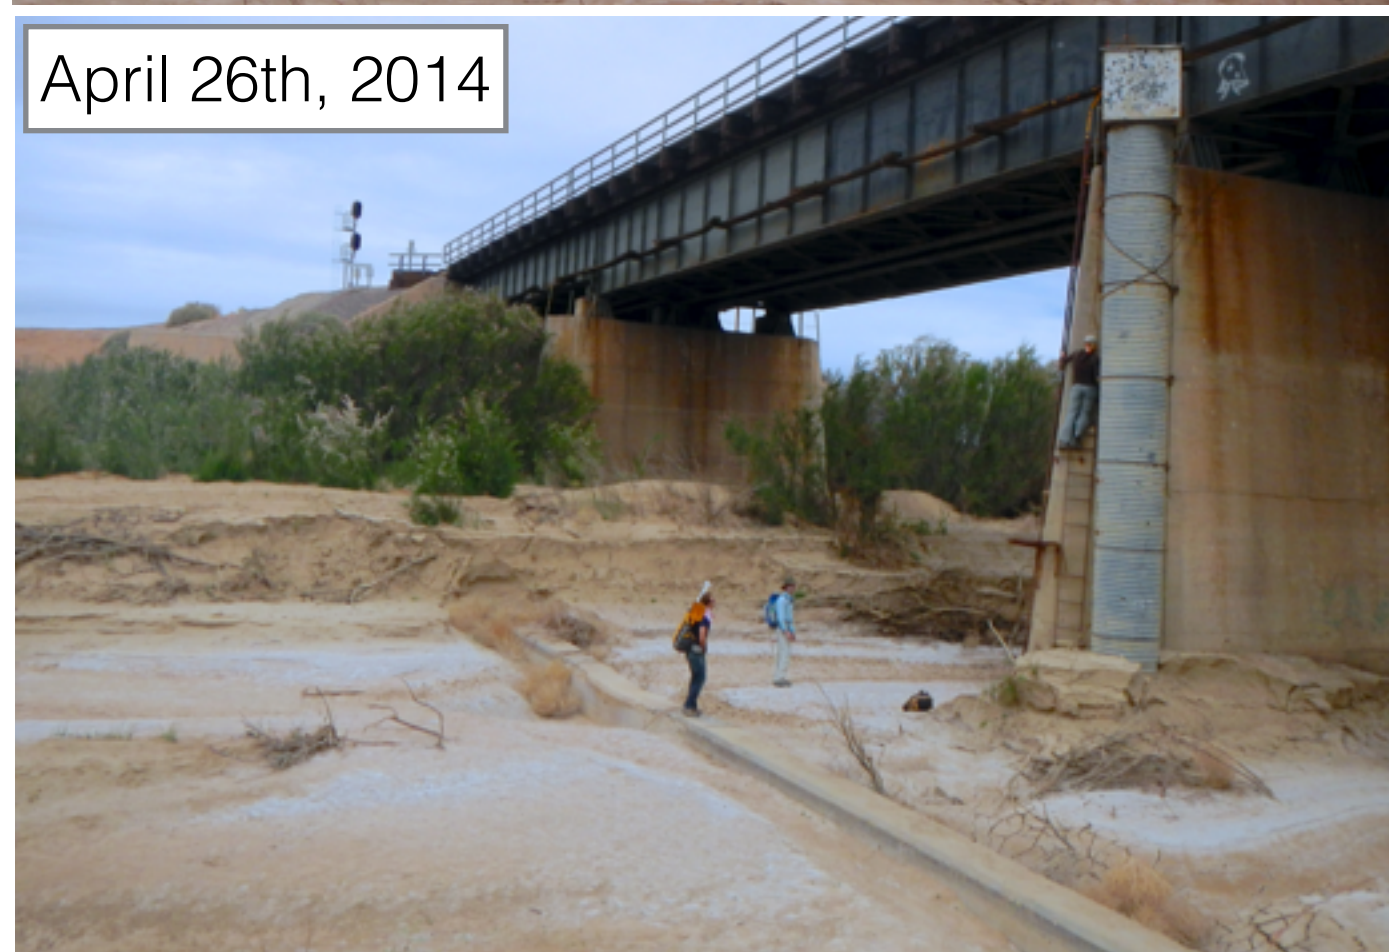
April 26th, 2014

Evolving channel **shape**  
**Vegetation** cover

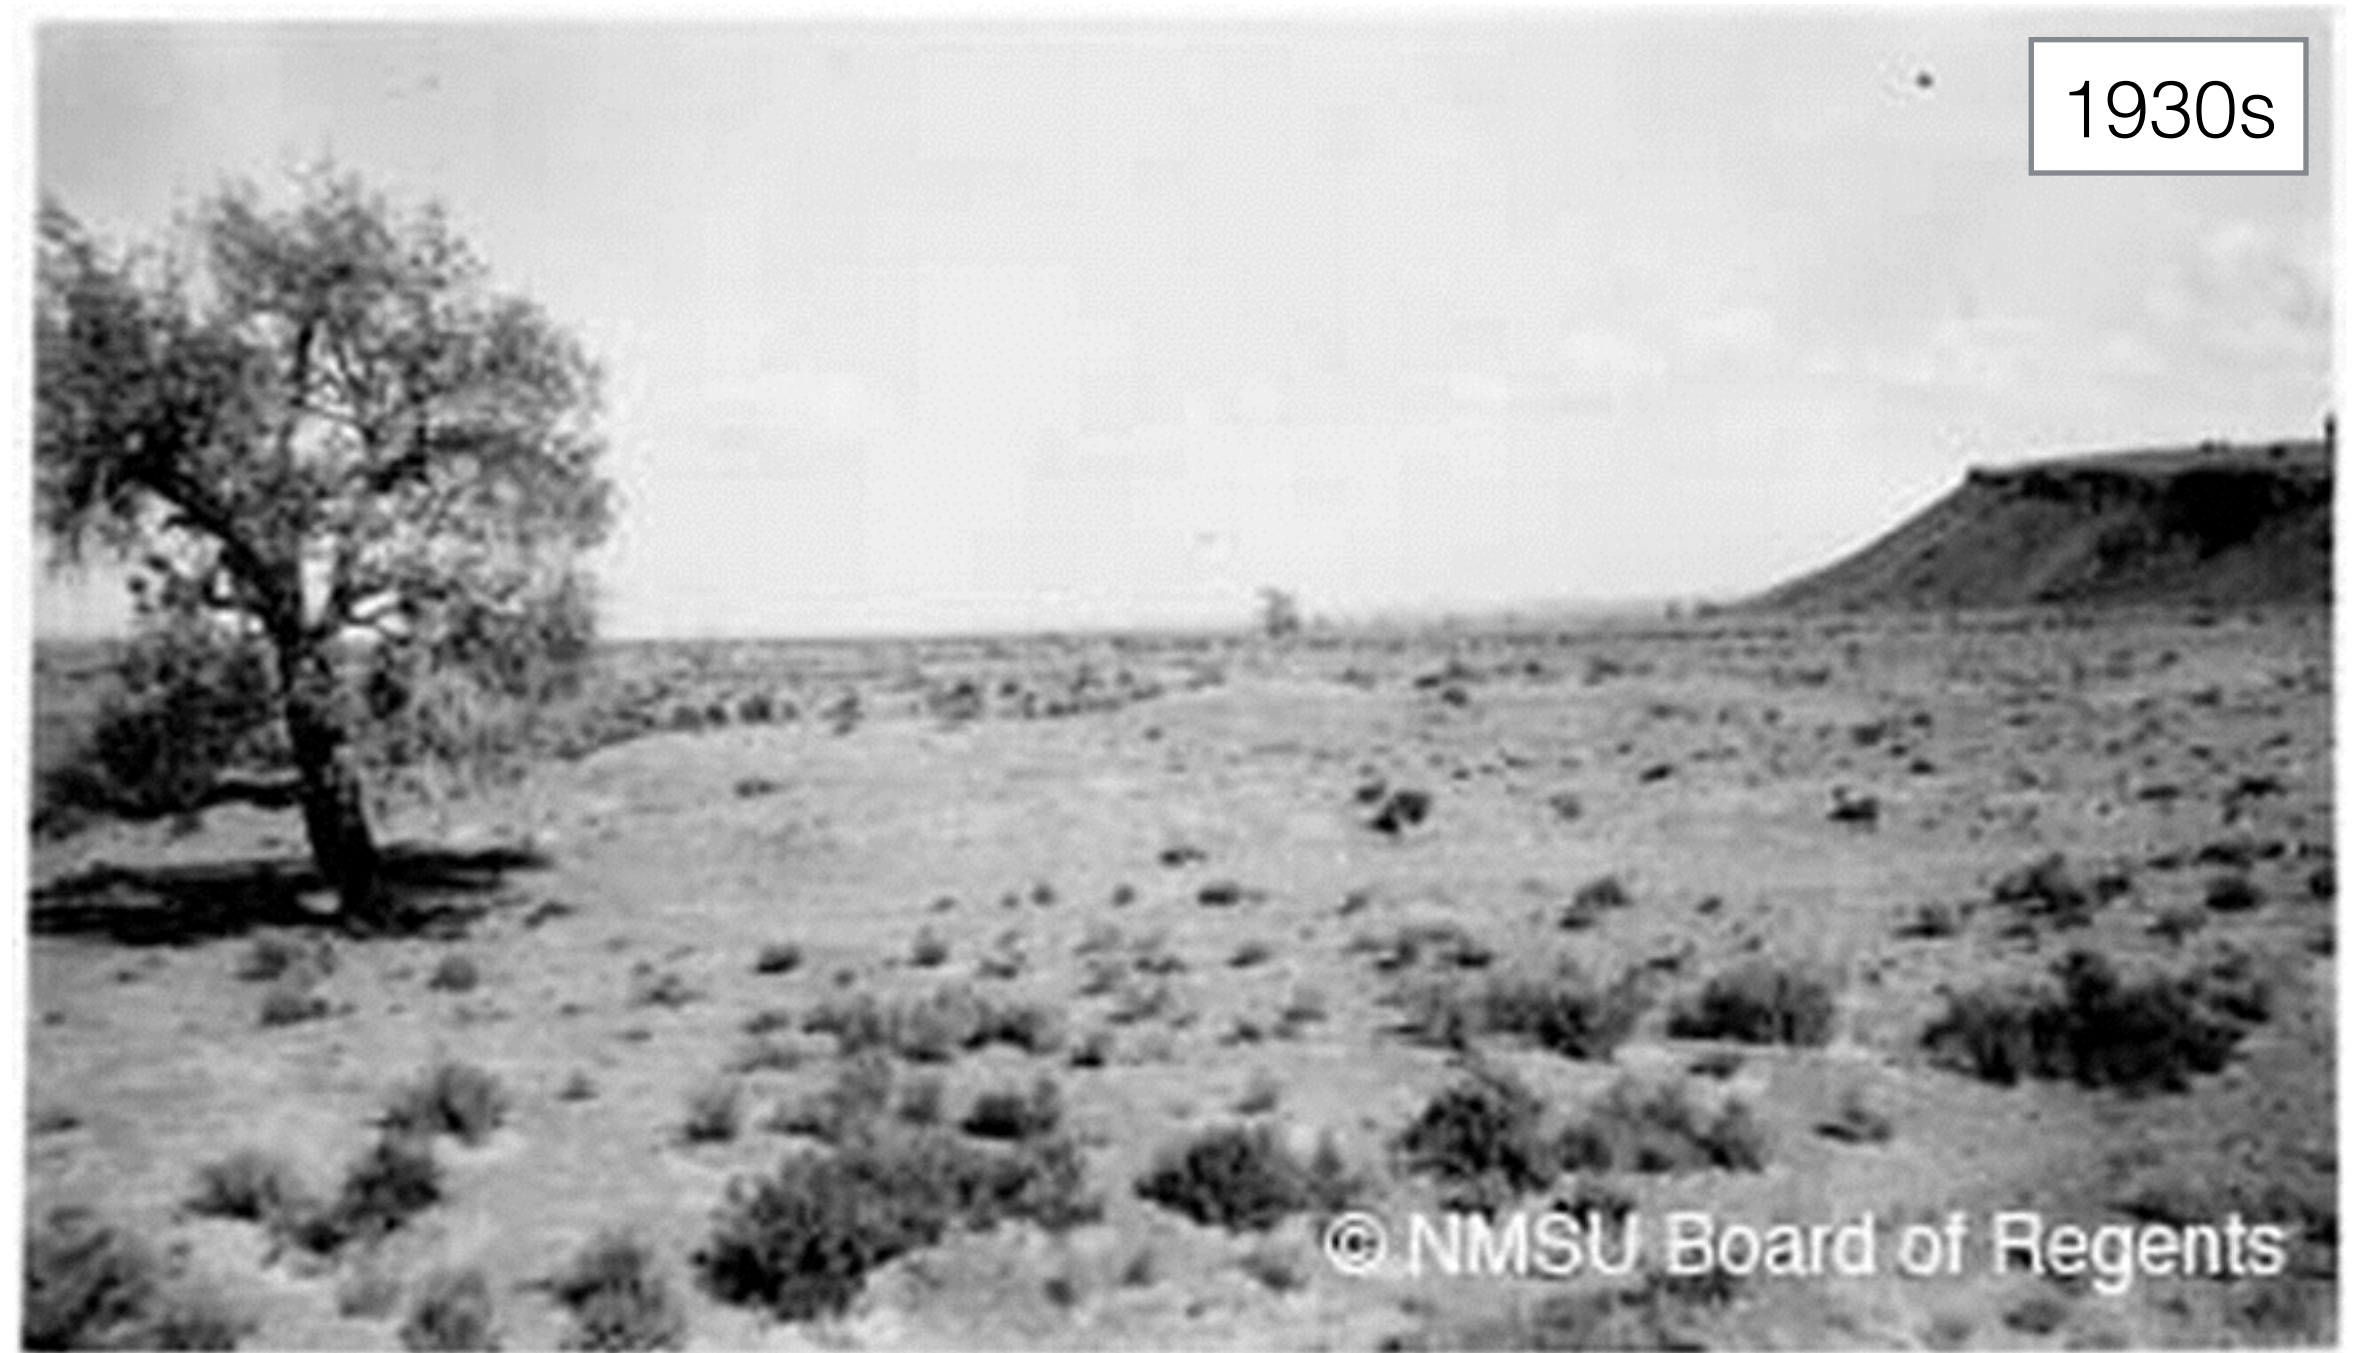
Native **sandbar willow** on banks, **cottonwoods** on floodplains  
Much denser invasive **tamarisk** on levees

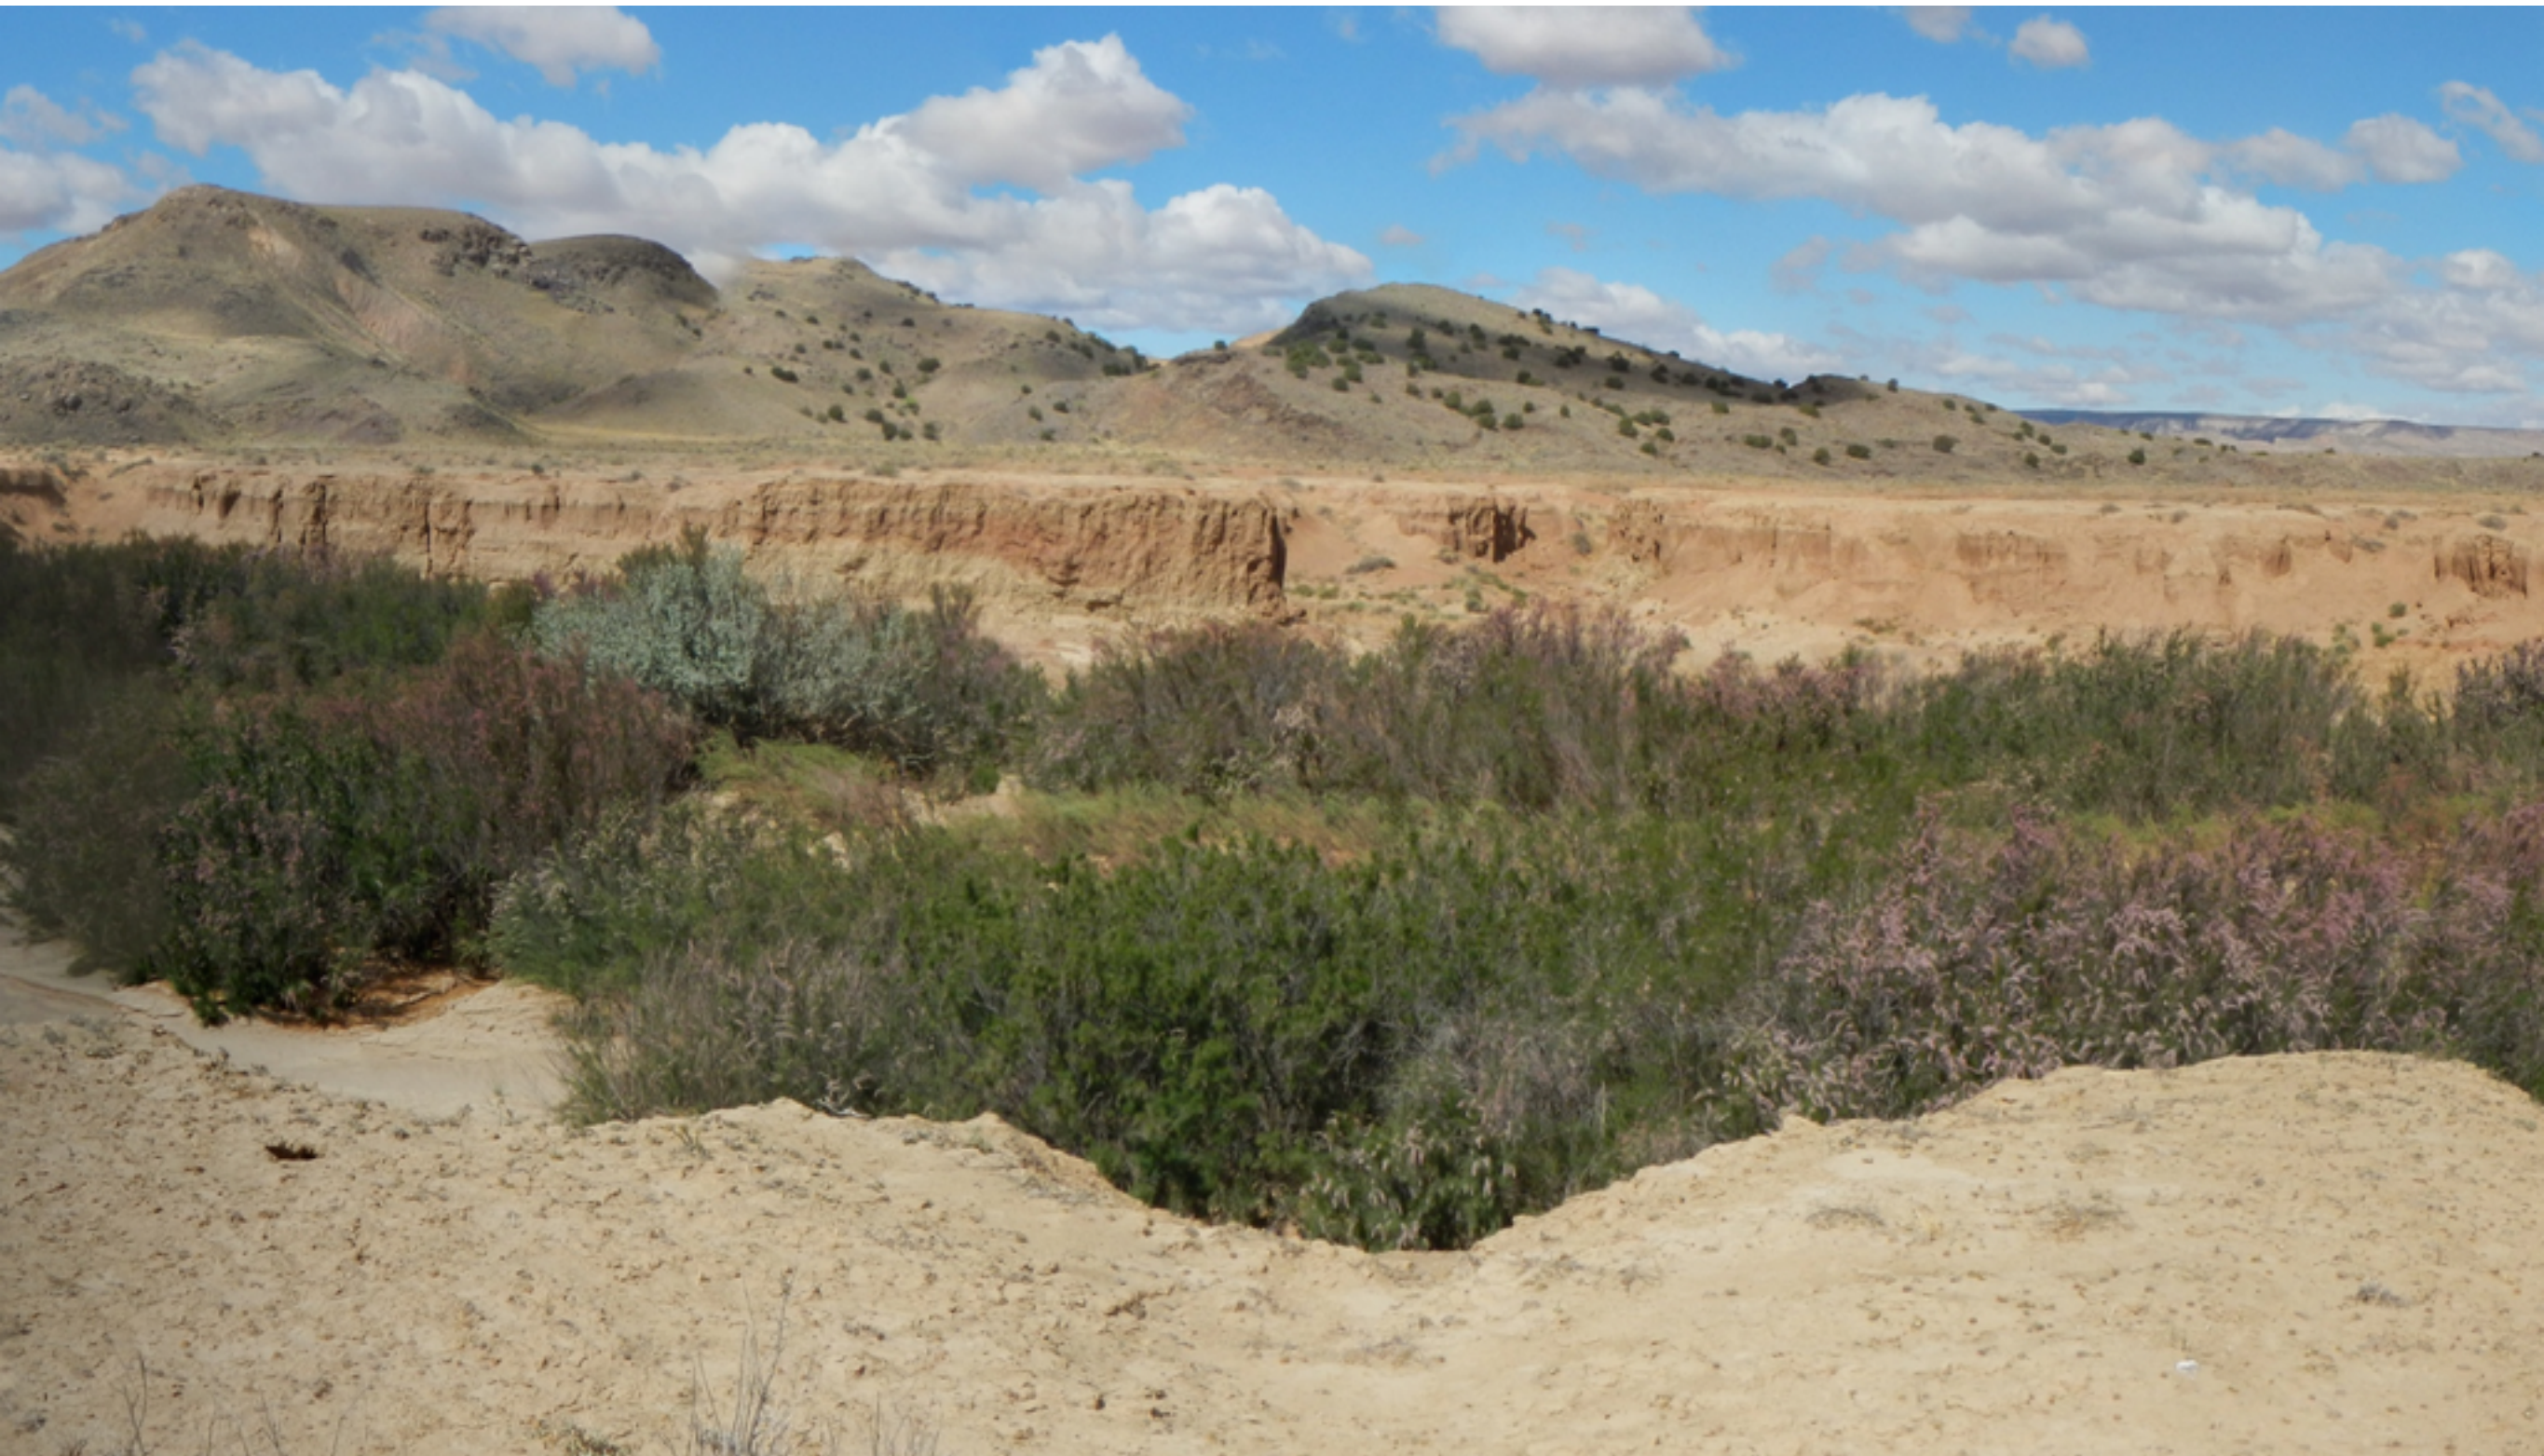
Native **sandbar willow** on banks, **cottonwoods** on floodplains

Much denser invasive **tamarisk** on levees
