# The Rio Puerco, New Mexico: a story of changing river morphology and invasive species

# Rio Puerco, New Mexico:

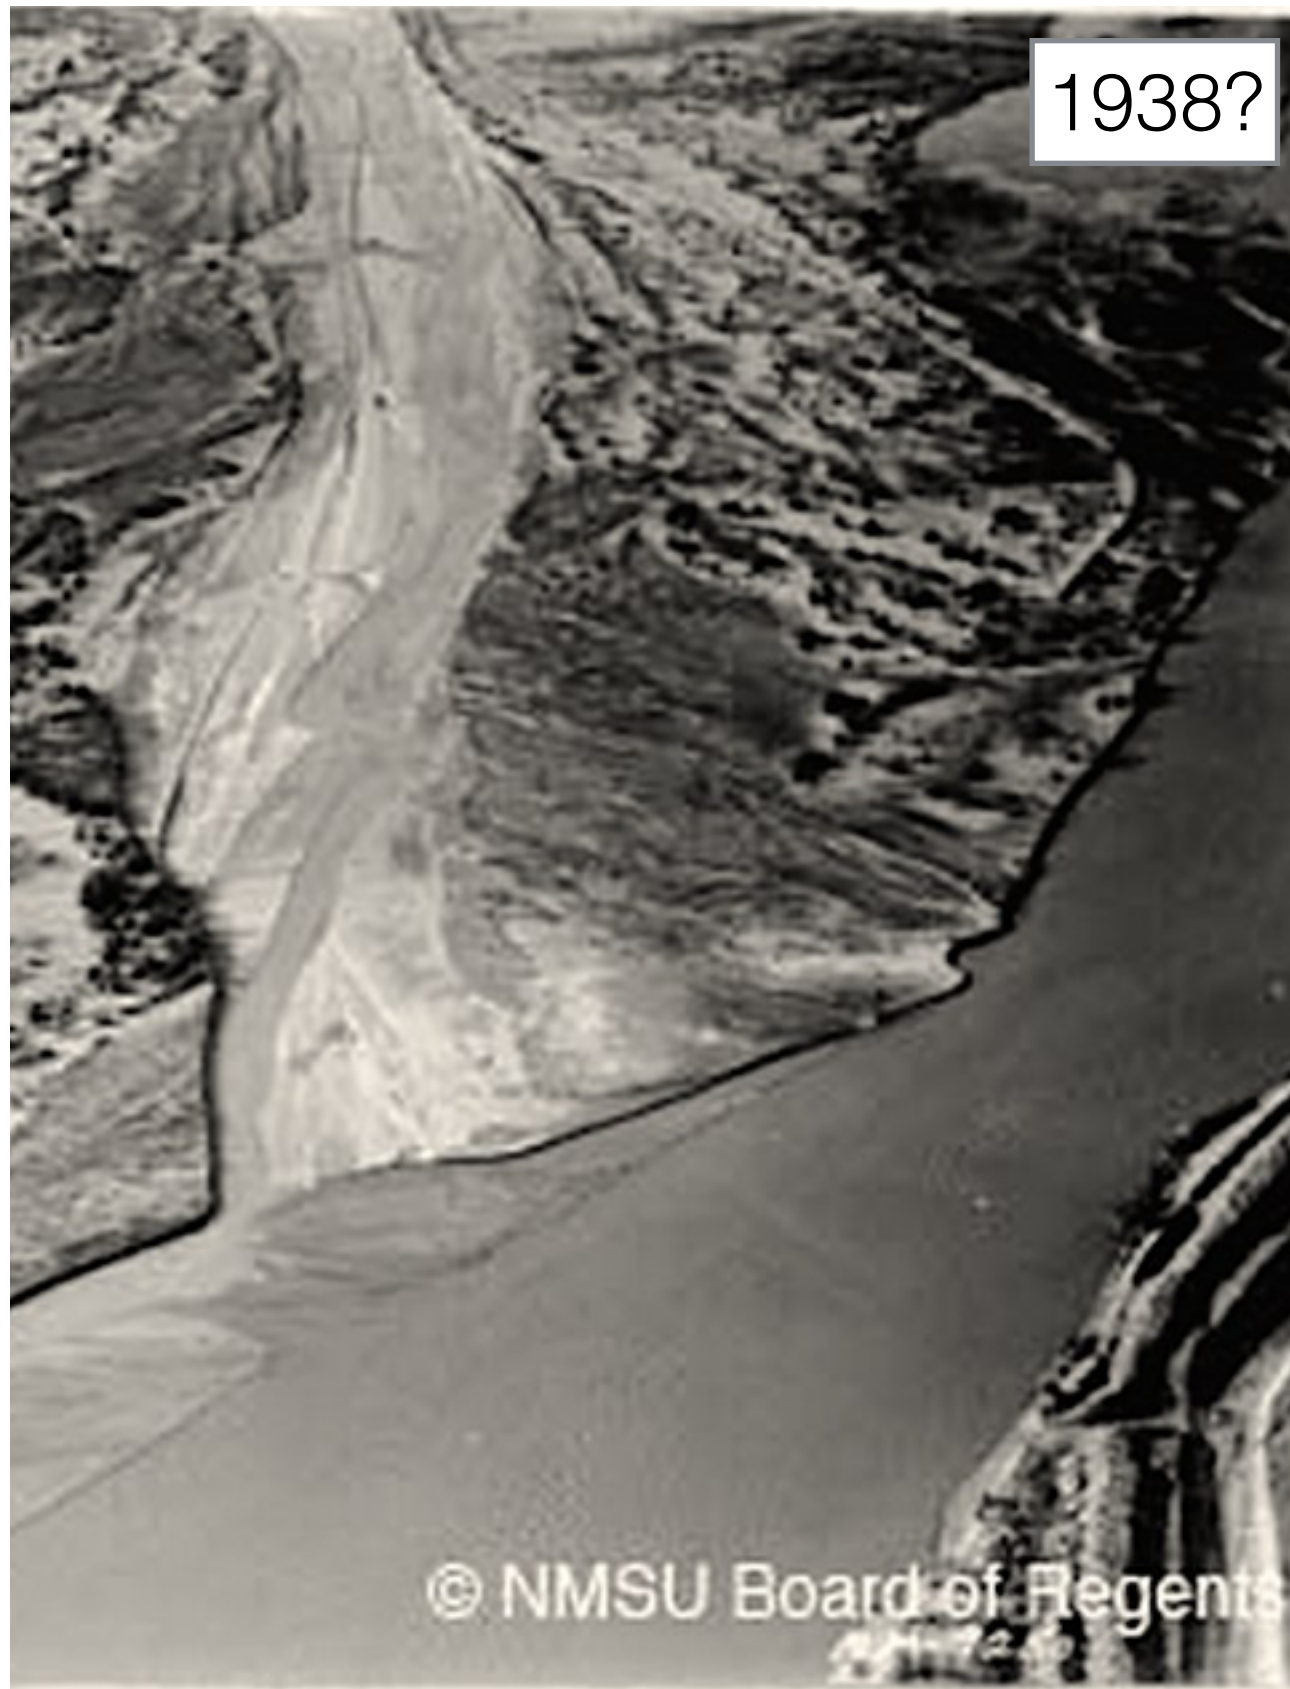
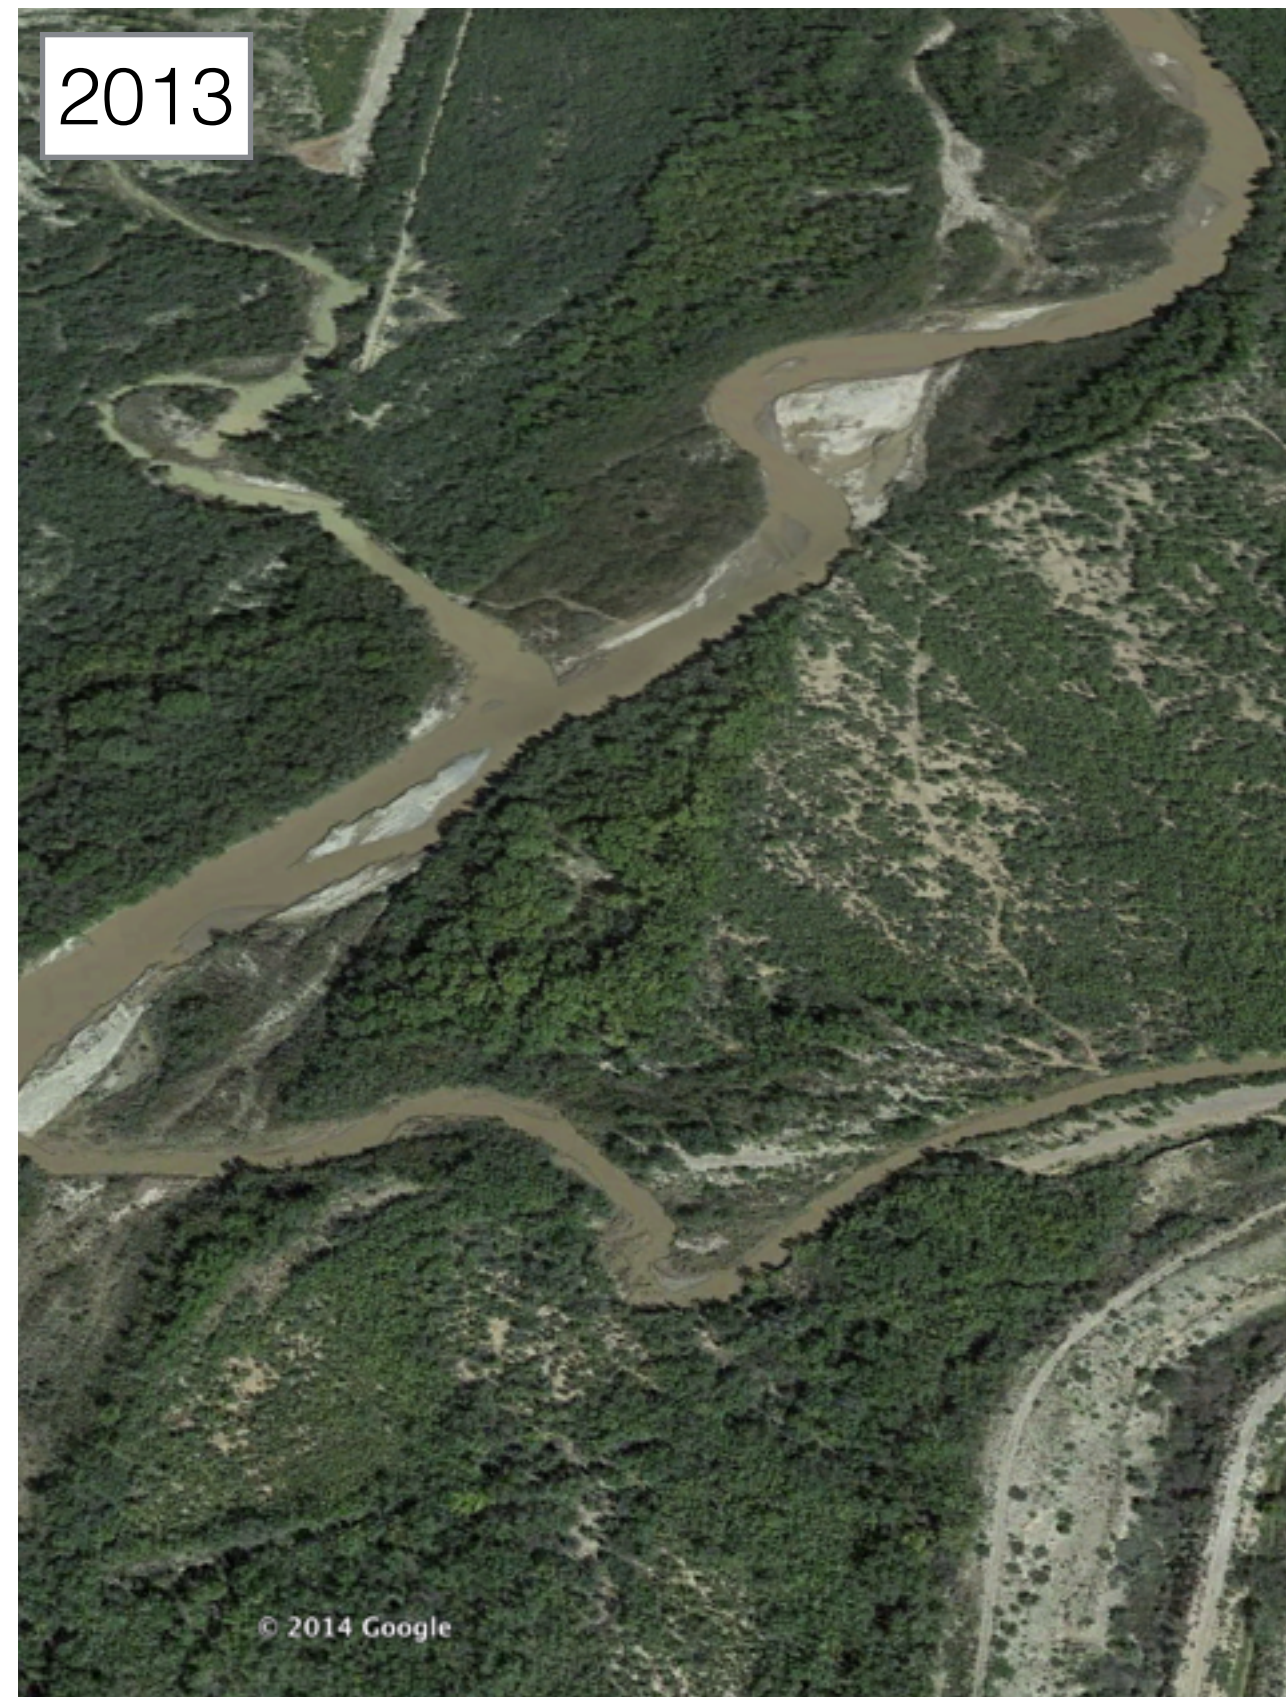
Up to 1930s, high **sediment load** to Rio Grande  
Now, channel **narrowing**, stability

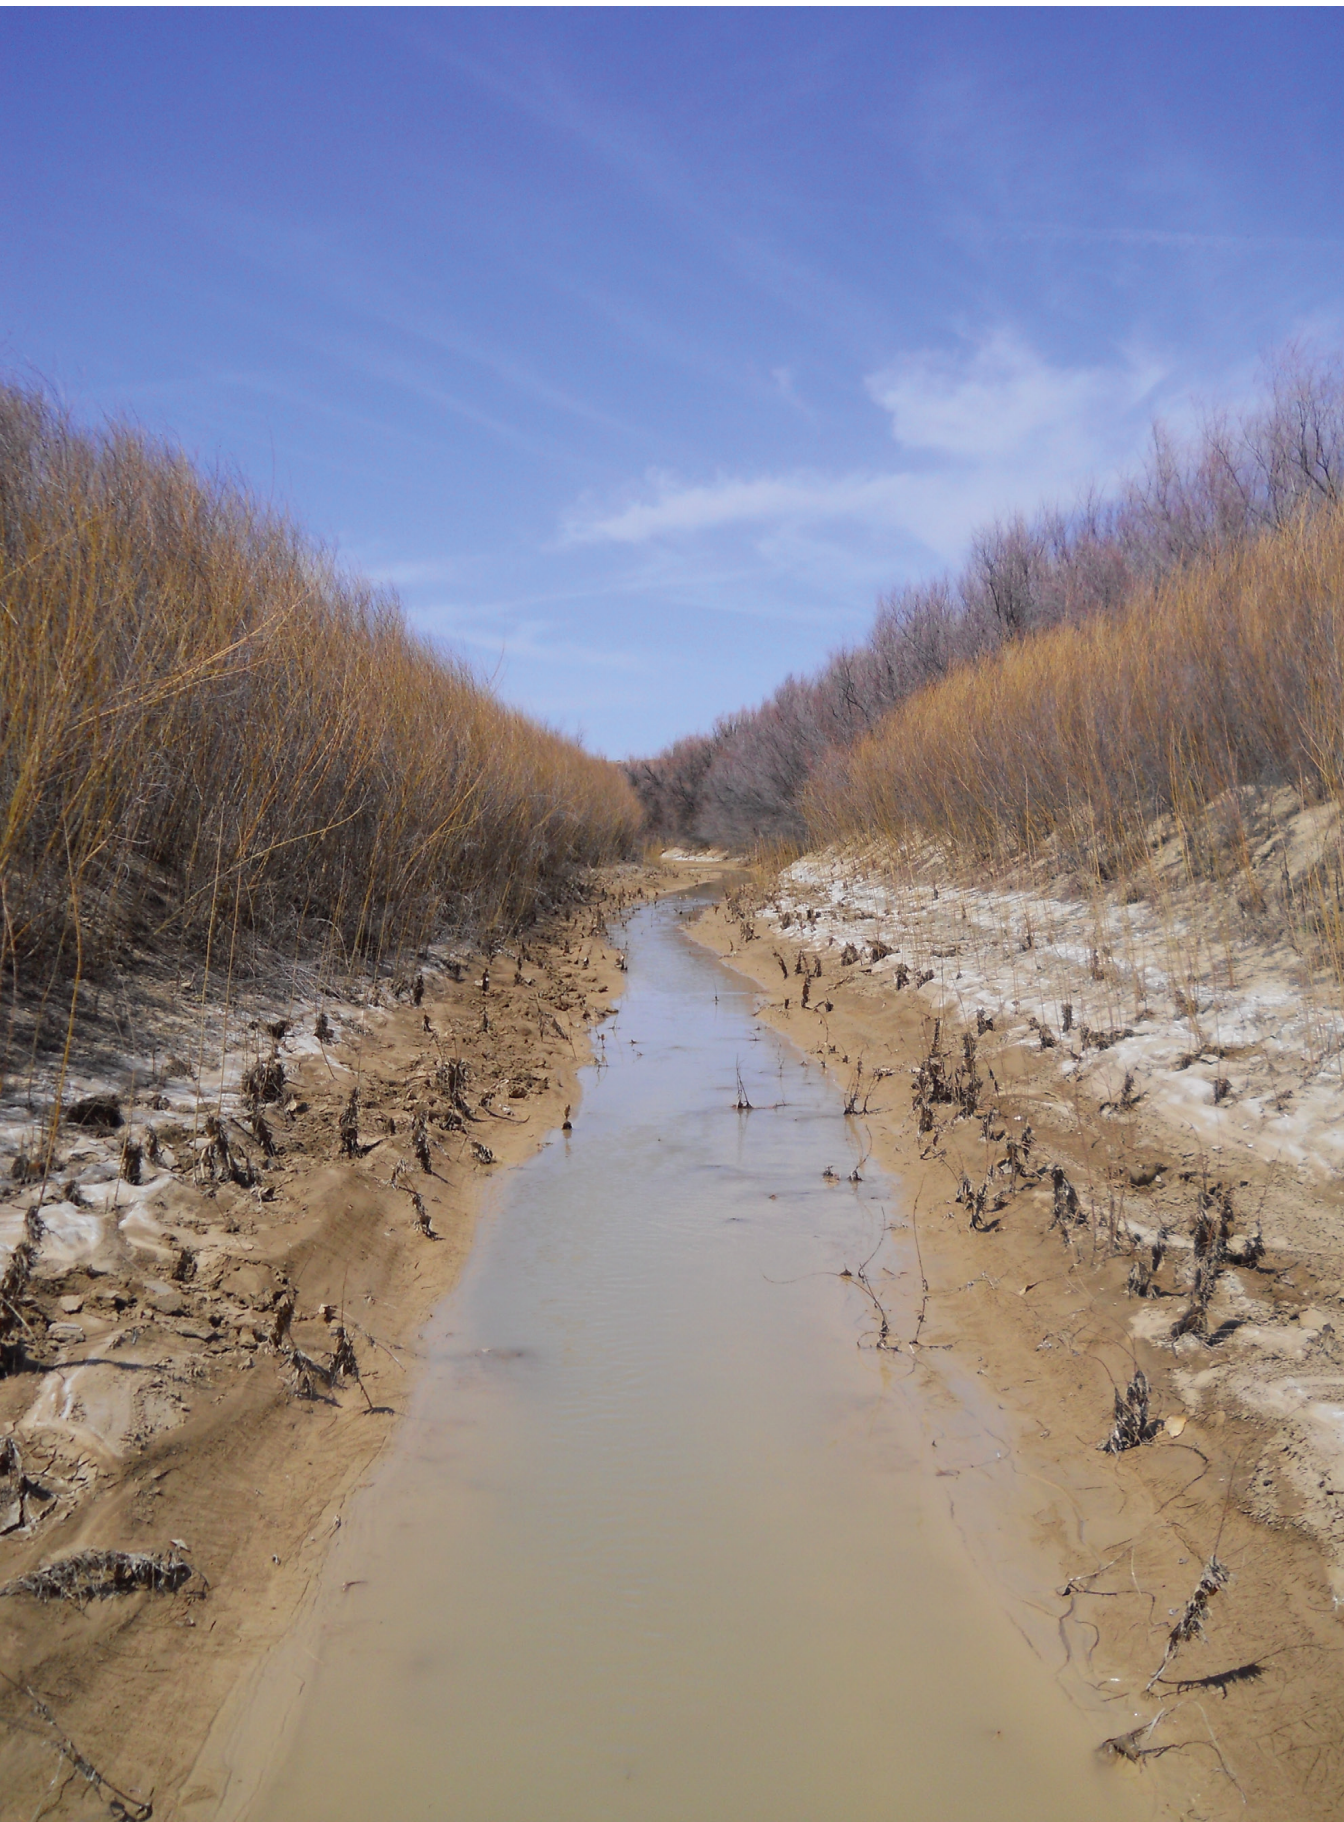
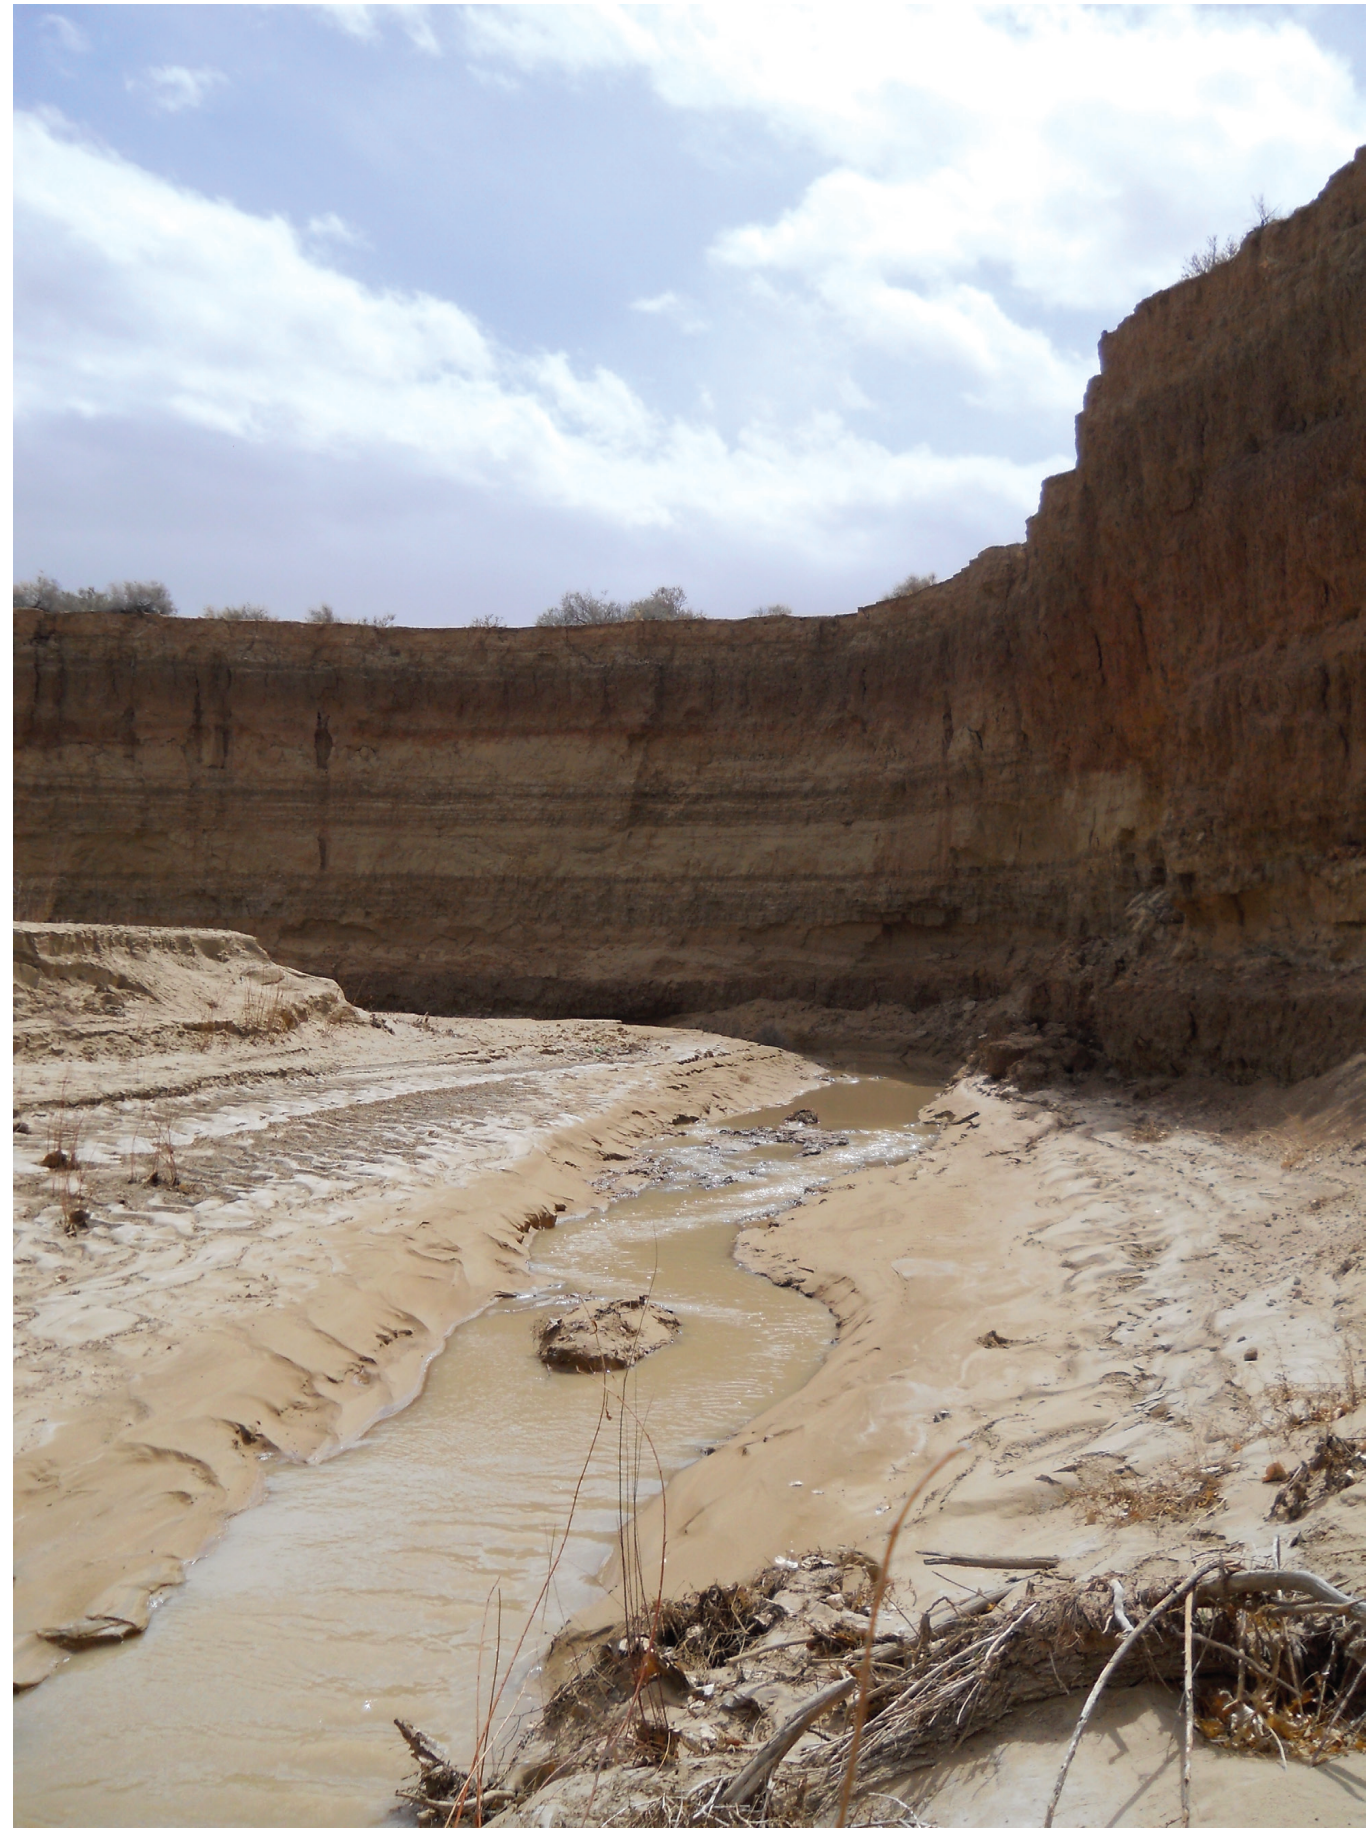
Attempts at tamarisk removal:  
Channel **widening**, wall **retreat**

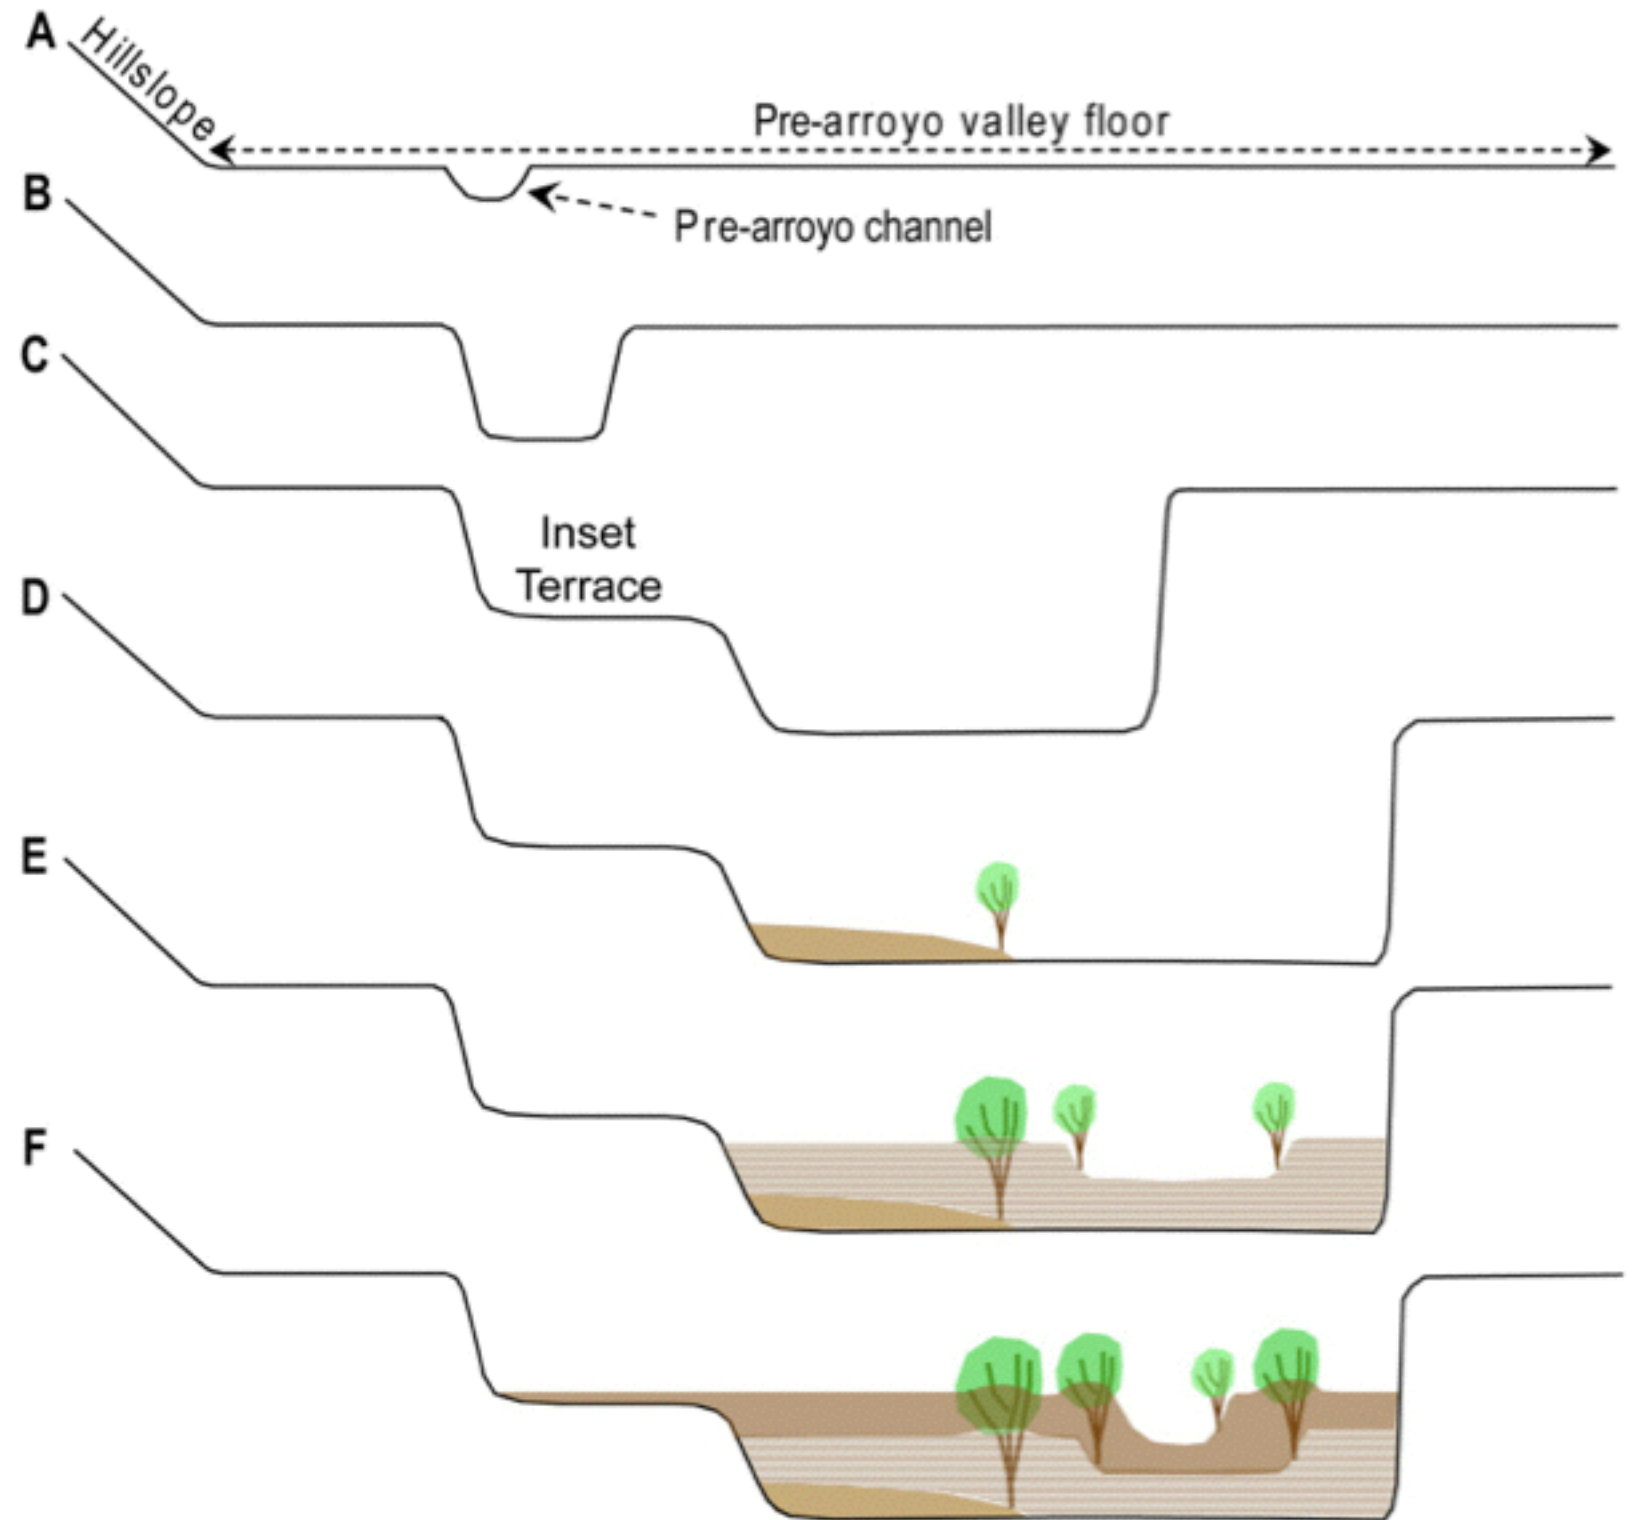
Fully filled / pre-incision

Incision

Widening /  
floodplain development

Filling

Present day
