Barrier Island Recovery After an Outwash Event

Chris Sherwood¹, Jin-Si Over¹

¹US Geological Survey, Woods Hole, MA, ²US Geological Survey, Santa Cruz, CA, ³US Geological Survey, St. Petersburg, FL

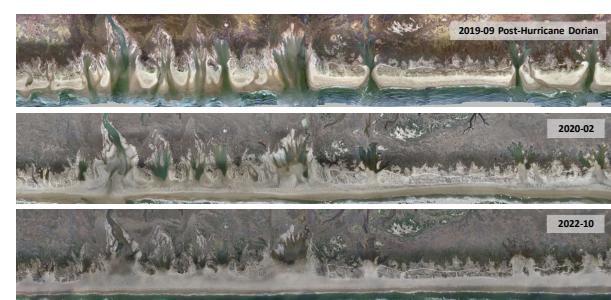
Initial Recovery Created Scores of Ponds Days after the storm, spits and swash bars started closing the channels. Months later, a continuous berm was restored, and nearly all the channels were partially filled. After three years, the frequency of overwash has decreased

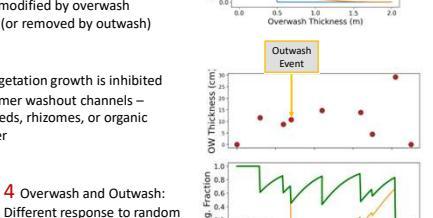
Lack of Revegetation in Sterile Soil - Conceptual Model

(or removed by outwash 3 Vegetation growth is inhibited in former washout channels no seeds, rhizomes, or organic

1 Vegetation growth depends

2 Vegetation cover is

modified by overwash

4 Overwash and Outwash
